# Access Compliance Report

## Public Rights-of-Way

### (Curb Ramps)

Intersection ID: 14066	Main Street: MARKLAND_DR	Cross Street: MAYFAIR_AV	Location: S
ADA ID: 2B1C542F84F3	Ramp Type: Perp	Initial Pass/Fail: Fail	Overall Compliance: No
			Severity Score: 21.25

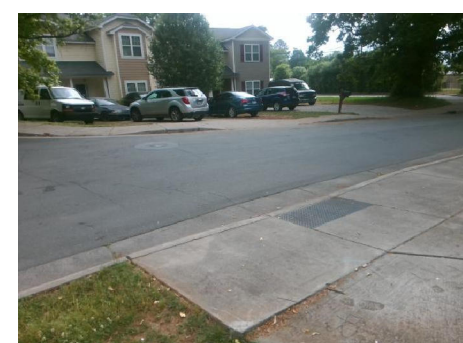
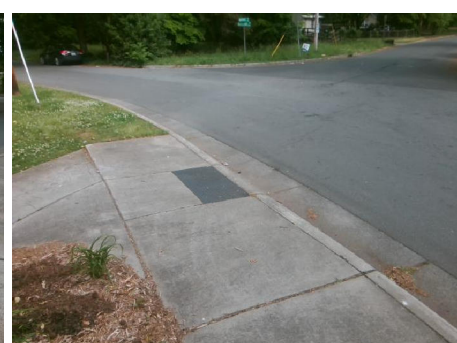
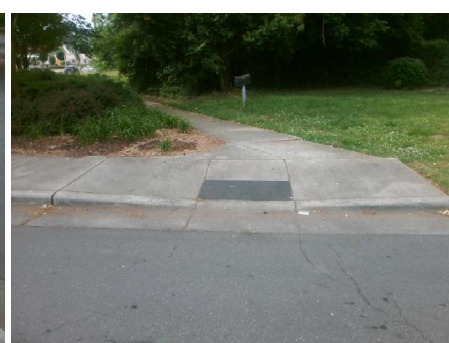
Possible Solutions:		<b>Compliance</b>	<b>Description</b>	<b>Data</b>
	Remove & Replace Entire Ramp.		N/A	Ramp Length (in)	60.0
			No	Ramp Width (in)	47.0
			N/A	Flare Type LT	N/A
			N/A	Flare Slope LT (%)	N/A
			N/A	Flare Traversable LT?	N/A
			N/A	Landing Length (in)	N/A
			N/A	Landing Width (in)	N/A
			N/A	Landing Slope (%)	N/A
			N/A	Landing X Slope (%)	N/A
<p>Surveyor Notes:</p> <p>N/A</p> <p>PROW/ADA:</p> <p>Not Found, R304.5.1, R304.2.2</p>			N/A	Flare Type RT	N/A
			N/A	Flare Slope RT (%)	N/A
			N/A	Flare Traversable RT?	N/A
			N/A	DWS Provided?	N/A
			N/A	DWS Contrast?	N/A
			N/A	DWS Length (in)	N/A
			N/A	DWS Full Width?	N/A
			N/A	DWS Offset (in)	N/A
			N/A	Shared Landing?	N/A
			N/A	Gutter Ponding?	N/A
			N/A	Gutter Lip Ht (in)	N/A
			N/A	Painted X Walk1?	No
				X Walk 1 Direction	To N
			N/A	X Walk 1 Width (in)	N/A

X Walk 1 Slope (%)	2.1
				X Walk 1 X Slope (%)	2.3
			N/A	Ramp inside XWalk1?	N/A
				Road Slope (%)	N/A
				Road X Slope (%)	N/A
			N/A	Any Obstructions?	N/A
				Obstruction Type	
Total Cost:		\$ 1850.00			
			N/A		N/A
			Yes	Surface Condition? (G/P)	Good
