Access Compliance Report

Public Rights-of-Way (Curb Ramps)

Intersection ID: 11413		Main Street: EAST_FORD_RD		Cross Street: SHAMROCK_DR		Location: SW			
ADA ID: 2C308E3670C8		Ramp Type: Directional1		Initial Pass/Fail: Fail		Overall Compliance: No		Severity Score: 12.5	
Codes/Mitigation Info/Possible Solution				Field Measurements/Component Compliance					
<div>

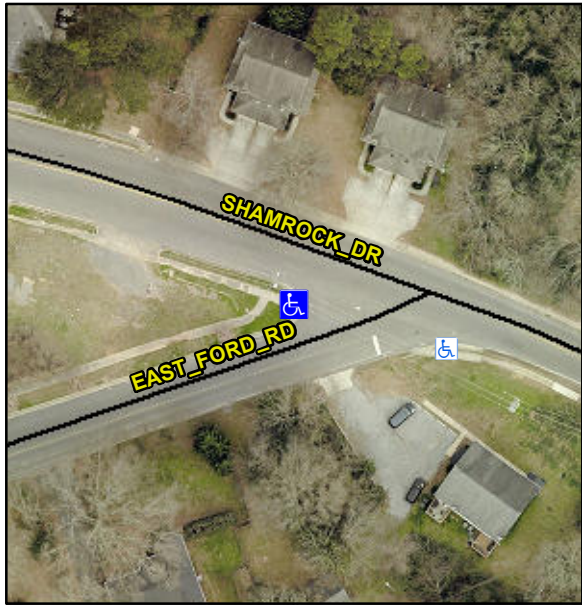
Yes	Ramp XSlope (%)	0.6			
				N/A	Flare Type LT	N/A	N/A	Flare Type RT	N/A
				N/A	Flare Slope LT (%)	N/A	N/A	Flare Slope RT (%)	0.0
				N/A	Flare Traversable LT?	N/A	N/A	Flare Traversable RT?	N/A
				N/A	Landing Length (in)	0.0	N/A	DWS Provided?	N/A
				N/A	Landing Width (in)	0.0	N/A	DWS Contrast?	N/A
				N/A	Landing Slope (%)	0.0	N/A	DWS Length (in)	N/A
				N/A	Landing X Slope (%)	0.0	N/A	DWS Full Width?	N/A
				N/A	Landing Curb? (Y/N)	N/A	N/A	DWS Offset LT (in)	N/A
				N/A	Shared Landing?	N/A	N/A	DWS Offset RT (in)	N/A
				N/A	Gutter Ponding?	0.0	N/A	Gutter Slope (%)	N/A
				N/A	Gutter Lip Ht (in)	0.0	N/A	Gutter X Slope (%)	N/A
				N/A	Painted X Walk1?	No		Road Slope (%)	0.8
					X Walk 1 Direction	To SE		Road X Slope (%)	4.9
					X Walk 1 Width (in)	N/A		Clear Space?	N/A
					X Walk 1 Slope (%)	0.8	N/A	Clear Space to XWalk (in)	N/A
					X Walk 1 X Slope (%)	4.9	N/A	Storm Grate/Utility Hazard?	N/A

N/A	Ramp inside XWalk1?	N/A		Storm Grate/Utility Type	
				N/A	Any Obstructions?	N/A			N/A
					Obstruction Type		Yes	Surface Condition? (G/P)	Good
							N/A	Curb Slope (%)	9.0

</div> <div>Possible Solutions:</div> <div>Remove & Replace Entire Ramp.</div> <div>Surveyor Notes:</div> <div>N/A</div> <div>PROW/ADA:</div> <div>R304.2.2</div> <div>Street 1 Name</div> <div>EAST FORD RD</div> <div>Stop Condition-Street 1</div> <div>StopSign</div> <div>Street 2 Name</div> <div>N/A</div> <div>Stop Condition-Street 2</div> <div>N/A</div> <div>Total Cost:</div> <div>\$</div> <div>1600.00</div>				Compliance	Description	Data	Compliance	Description	Data
				N/A	Ramp Length (in)	120.0	N/A	Grade Break?	N/A
				Yes	Ramp Width (in)	54.0	N/A	Grade Break Slope (%)	0.0
				No	Ramp Slope (%)	10.6	N/A	Grade Break XSlope (%)	0.0
