Access Compliance Report

Public Rights-of-Way

(Curb Ramps)

Intersection ID: 8118	Main Street: DR_WEBBER_AV	Cross Street: CUSTER_ST	Location: SE
ADA ID: 2CABCB6B29F3	Ramp Type: Perp	Initial Pass/Fail: Fail	Overall Compliance: No
		Severity Score: 12.5

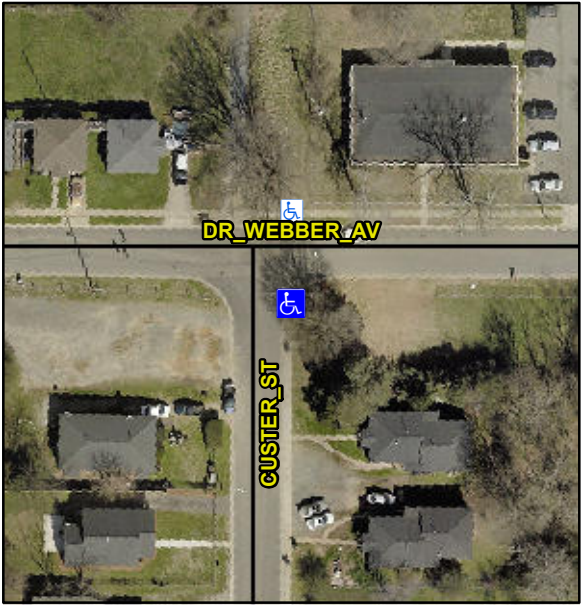
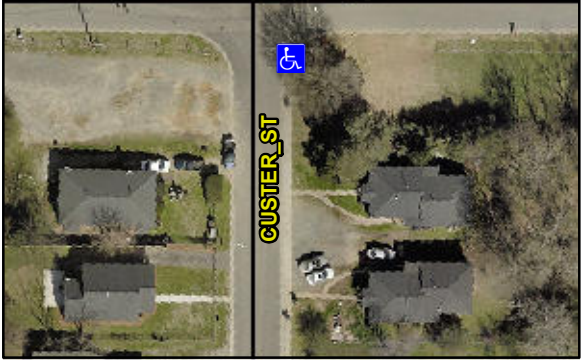
Surveyor Notes:		No	Ramp Slope (%)	8.5
	N/A		Yes	Ramp XSlope (%)	1.4

Possible Solutions:		Compliance	Description	Data
	Remove & Replace Entire Ramp.		Compliance	Description	Data
