# Access Compliance Report

## Public Rights-of-Way

| Intersection ID: 13086 | Main Street: CENTRAL_AV | Cross Street: CLEMENT_AV | Location: NE |
| ADA ID: 2CD5B61209A1 | Ramp Type: Perp | Initial Pass/Fail: Fail | Overall Compliance: No |

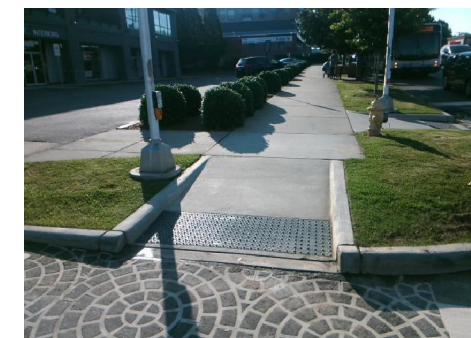
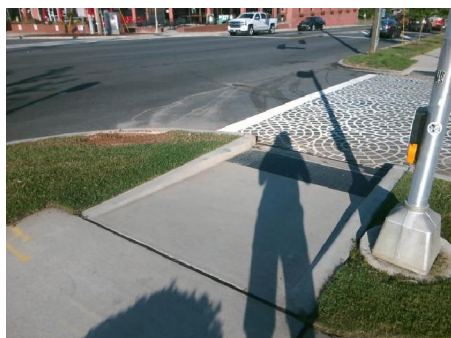
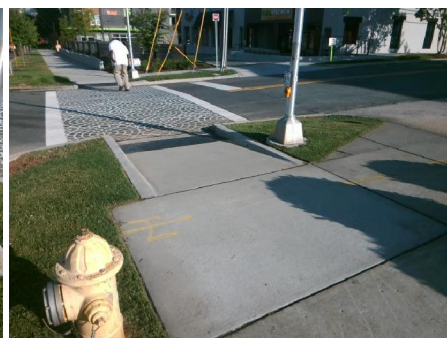
| Compliance | Description | Data | Compliance | Description | Data |
|---|---|---|---|---|---|
| N/A | Ramp Length (in) | 99.0 | No | Ramp Slope (%) | 9.9 |

**Remove & Replace Entire Ramp.**
