# Access Compliance Report

## Public Rights-of-Way

### (Curb Ramps)

Intersection ID: 14078	Main Street: EAST_BV	Cross Street: SOUTH_BV	Location: NE
ADA ID: 2CD84CCA6886	Ramp Type: BlendTrans2	Initial Pass/Fail: Fail	Overall Compliance: No
		Severity Score: 10

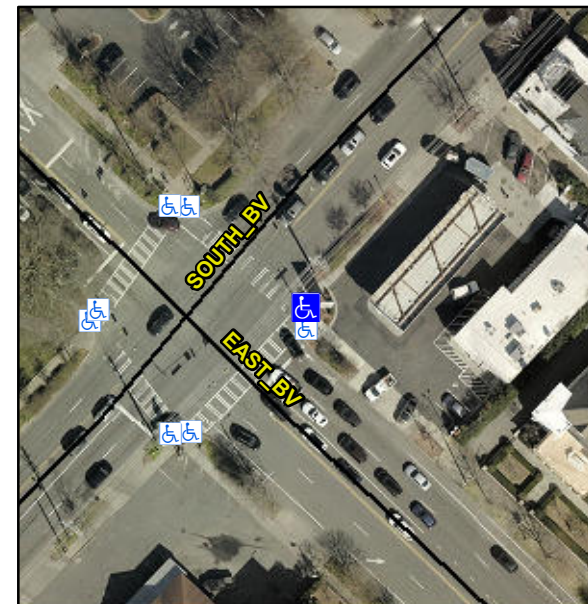
**Not Found, R304.5.1, R304.5.3**

Compliance	Description	Data	Compliance	Description	Data
N/A	Ramp Length (in)	29.0	Yes	BlendTrans Slope (%)	3.5
No	Ramp Width (in)	37.0	No	BlendTrans XSlope (%)	2.3
N/A	Flare Type LT	N/A	N/A	Flare Type RT	N/A
N/A	Flare Slope LT (%)	N/A	N/A	Flare Slope RT (%)	N/A
N/A	Flare Traversable LT?	N/A	N/A	Flare Traversable RT?	N/A
N/A	Landing Length (in)	N/A	N/A	DWS Provided?	N/A
N/A	Landing Width (in)	N/A	N/A	DWS Contrast?	N/A
N/A	Landing Slope (%)	N/A	N/A	DWS Length (in)	N/A
N/A	Landing X Slope (%)	N/A	N/A	DWS Full Width?	N/A
N/A	Landing Curb? (Y/N)	N/A	N/A	DWS Offset (in)	N/A
N/A	Shared Landing?	N/A			
N/A	Gutter Ponding?	N/A	N/A	Gutter Slope (%)	N/A
N/A	Gutter Lip Ht (in)	N/A	N/A	Gutter X Slope (%)	N/A
N/A	Painted X Walk1?	Yes	N/A	Painted X Walk2?	N/A
	X Walk 1 Direction	To NW		X Walk 2 Direction	N/A
	X Walk 1 Width (in)	120.0		X Walk 2 Width (in)	N/A
	X Walk 1 Slope (%)	2.0		X Walk 2 Slope (%)	N/A
	X Walk 1 X Slope (%)	1.2		X Walk 2 X Slope (%)	N/A

N/A	Ramp inside XWalk1?	Yes	N/A	Ramp inside XWalk2?	N/A
	Road Slope (%)	1.2		Clear Space?	N/A
	Road X Slope (%)	2.0	N/A	Clear Space to XWalk (in)	N/A
N/A	Any Obstructions?	N/A	N/A	Storm Grate/Utility Hazard?	N/A
	Obstruction Type			Storm Grate/Utility Type	
		N/A			N/A
			Yes	Surface Condition? (G/P)	Good
			No	Curb Slope (%)	14.1

**Remove & Replace Curb Ramp With Two New Directional Ramps or Equivalent.**
