# Access Compliance Report

## Public Rights-of-Way

### (Curb Ramps)

Intersection ID: 26384	Main Street: BEVINGTON_PL	Cross Street: ELM_LN	Location: SW
ADA ID: 2DA1B25E2264	Ramp Type: Perp	Initial Pass/Fail: Fail	Overall Compliance: No Severity Score: 13.75

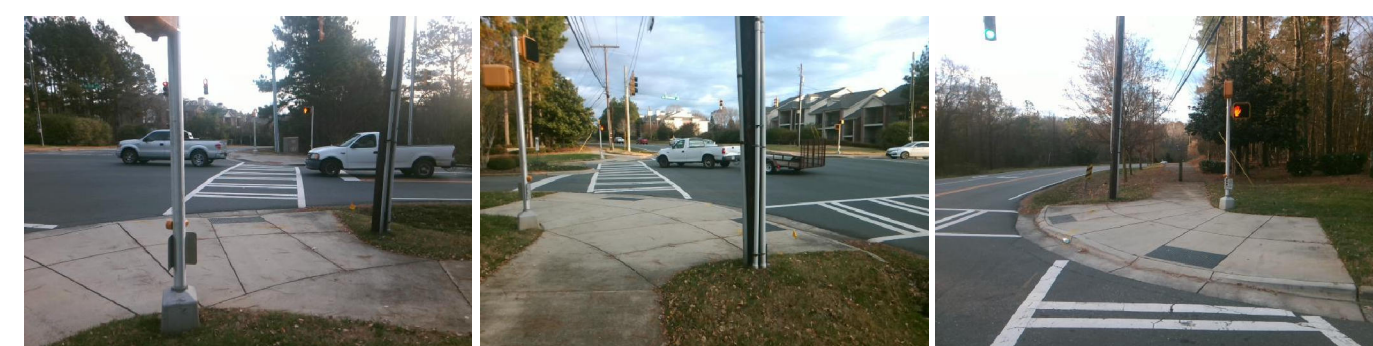
Possible Solutions:		<b>Compliance</b>	<b>Description</b>	<b>Data</b>
	<b>Remove &amp; Replace Entire Ramp.</b>		<b>No</b>	Ramp Length (in)	71.0
			<b>Yes</b>	Ramp Width (in)	50.0
			<b>N/A</b>	Flare Type LT	N/A
			<b>N/A</b>	Flare Slope LT (%)	N/A
			<b>N/A</b>	Flare Traversable LT?	N/A
			<b>N/A</b>	Landing Length (in)	N/A
			<b>N/A</b>	Landing Width (in)	N/A
			<b>N/A</b>	Landing Slope (%)	N/A
			<b>N/A</b>	Landing X Slope (%)	N/A
<p>Surveyor Notes:</p> <p><b>N/A</b></p> <p>PROW/ADA:</p> <p><b>Not Found, R304.2.2, R304.5.3</b></p>			<b>N/A</b>	Flare Type RT	N/A
			<b>N/A</b>	Flare Slope RT (%)	N/A
			<b>N/A</b>	Flare Traversable RT?	N/A
			<b>N/A</b>	DWS Provided?	N/A
			<b>N/A</b>	DWS Contrast?	N/A
			<b>N/A</b>	DWS Length (in)	N/A
			<b>N/A</b>	DWS Full Width?	N/A
			<b>N/A</b>	DWS Offset (in)	N/A
			<b>N/A</b>	Shared Landing?	N/A

<b>N/A</b>	Gutter Ponding?	N/A
			<b>N/A</b>	Gutter Lip Ht (in)	N/A
			<b>N/A</b>	Painted X Walk1?	Yes
				X Walk 1 Direction	To E
			<b>N/A</b>	X Walk 1 Width (in)	122.0
				X Walk 1 Slope (%)	4.5
				X Walk 1 X Slope (%)	3.7
			<b>N/A</b>	Ramp inside XWalk1?	Yes
			<b>N/A</b>	Road Slope (%)	N/A
			<b>N/A</b>	Road X Slope (%)	N/A
			<b>N/A</b>	Any Obstructions?	N/A
Total Cost:		\$ 1850.00		Obstruction Type	
			<b>N/A</b>	Clear Space?	N/A
			<b>N/A</b>	Clear Space to XWalk (in)	N/A
			<b>N/A</b>	Storm Grate/Utility Hazard?	N/A
				Storm Grate/Utility Type	
			<b>N/A</b>		N/A
			<b>Yes</b>	Surface Condition? (G/P)	Good
