Access Compliance Report

Public Rights-of-Way

(Curb Ramps)

Intersection ID: 10032191		Main Street: MORRISON_BV		Cross Street: N/A		Location:		SW									
ADA ID: 2DA87B13FC5D		Ramp Type: Directional1		Initial Pass/Fail: Fail		Overall Compliance: No		Severity Score: 1.25									
Codes/Mitigation Info/Possible Solution				Field Measurements/Component Compliance													
<div>

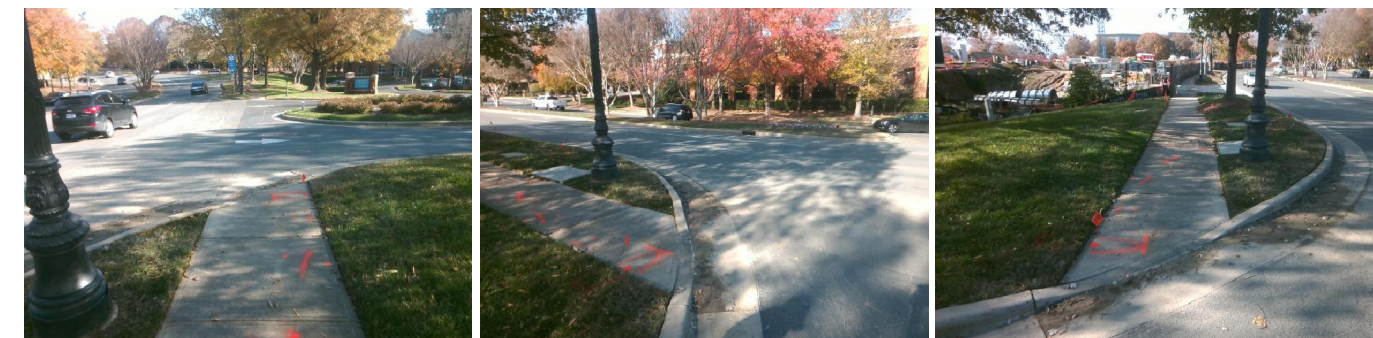
</div> <div>Street 1 NameENTRANCE</div> <div>Stop Condition-Street 1StopSign</div> <div>Street 2 NameN/A</div> <div>Stop Condition-Street 2N/A</div> <div>Possible Solutions: Remove & Replace Entire Ramp.</div> <div>Surveyor Notes: N/A</div> <div>PROW/ADA: R304.5.3</div> <div>Total Cost: \$ 1600.00</div>				Compliance		Description		Data		Compliance		Description		Data			
				N/A		Ramp Length (in)		52.0		N/A		Grade Break?		N/A			
				Yes		Ramp Width (in)		60.5		N/A		Grade Break Slope (%)		0.0			
				Yes		Ramp Slope (%)		6.6		N/A		Grade Break XSlope (%)		0.0			
				No		Ramp XSlope (%)		3.2
