# Access Compliance Report

## Public Rights-of-Way

### (Curb Ramps)

Intersection ID: 50607	Main Street: DENBUR_DR	Cross Street: STREAM_ORCHID_LN	Location: NE
ADA ID: 2E35C885E789	Ramp Type: Perp	Initial Pass/Fail: Fail	Overall Compliance: No
Severity Score: 8.75			
Codes/Mitigation Info/Possible Solution		Field Measurements/Component Compliance

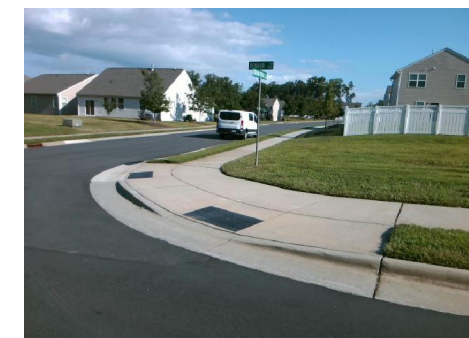
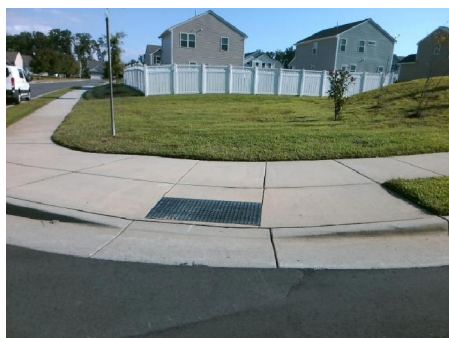
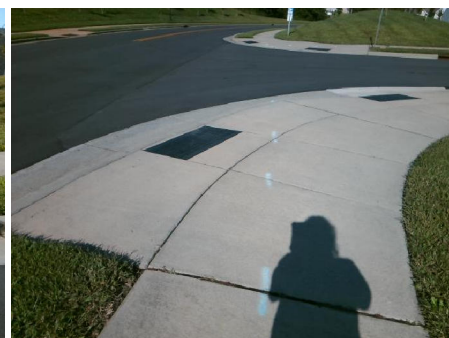
**Not Found, R304.5.1**

Compliance	Description	Data	Compliance	Description	Data
N/A	Ramp Length (in)	47.5	Yes	Ramp Slope (%)	7.6
No	Ramp Width (in)	47.5	Yes	Ramp XSlope (%)	1.1
N/A	Flare Type LT	N/A	N/A	Flare Type RT	N/A
N/A	Flare Slope LT (%)	N/A	N/A	Flare Slope RT (%)	N/A
N/A	Flare Traversable LT?	N/A	N/A	Flare Traversable RT?	N/A
N/A	Landing Length (in)	N/A	N/A	DWS Provided?	N/A
N/A	Landing Width (in)	N/A	N/A	DWS Contrast?	N/A
N/A	Landing Slope (%)	N/A	N/A	DWS Length (in)	N/A
N/A	Landing X Slope (%)	N/A	N/A	DWS Full Width?	N/A
N/A	Landing Curb? (Y/N)	N/A	N/A	DWS Offset (in)	N/A
N/A	Shared Landing?	N/A			
N/A	Gutter Ponding?	N/A	N/A	Gutter Slope (%)	N/A
N/A	Gutter Lip Ht (in)	N/A	N/A	Gutter X Slope (%)	N/A
N/A	Painted X Walk1?	No	N/A	Painted X Walk2?	N/A
	X Walk 1 Direction	To S		X Walk 2 Direction	N/A
N/A	X Walk 1 Width (in)	N/A	N/A	X Walk 2 Width (in)	N/A
	X Walk 1 Slope (%)	0.5		X Walk 2 Slope (%)	N/A
	X Walk 1 X Slope (%)	2.6		X Walk 2 X Slope (%)	N/A

**Remove & Replace Entire Ramp.**
