# Access Compliance Report

## Public Rights-of-Way

### (Curb Ramps)

| Intersection ID: 8904 | Main Street: FAIRMONT_ST | Cross Street: RUSSELL_AV | Location: SE |

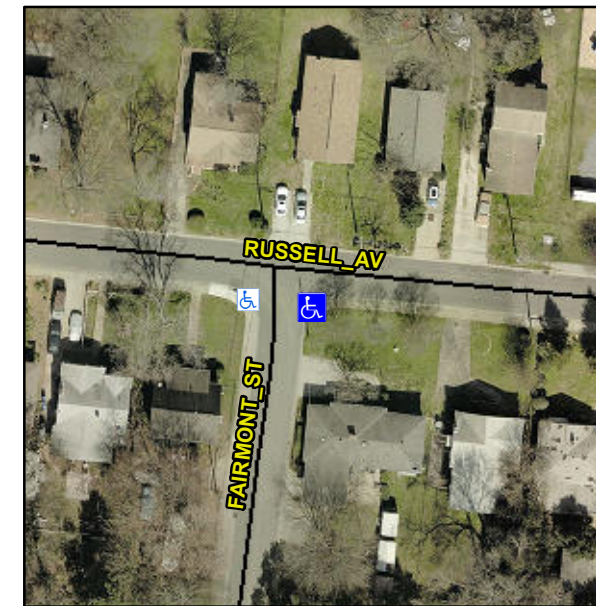
**NO RT SW**

**Not Found, R304.5.3**

| Compliance | Description | Data | Compliance | Description | Data |
|---|---|---|---|---|---|
| Yes | Ramp Width (in) | 48.0 | No | BlendTrans XSlope (%) | 3.3 |

**Remove & Replace Curb Ramp With Two New Directional Ramps or Equivalent.**
