Access Compliance Report

Public Rights-of-Way

(Curb Ramps)

Intersection ID: 44110	Main Street: GLENLUCE_AV	Cross Street: STAFFORDSHIRE_LN	Location: W
ADA ID: 2F31D99F6ED6	Ramp Type: PerpDiag	Initial Pass/Fail: Fail	Overall Compliance: No
Severity Score: 8.75			
Codes/Mitigation Info/Possible Solution		Field Measurements/Component Compliance

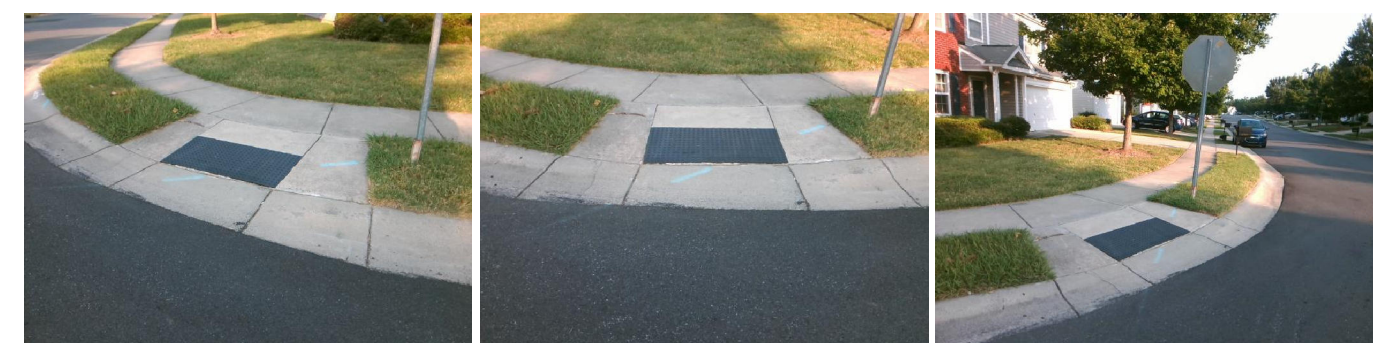
Not Found, R304.5.1

Compliance	Description	Data	Compliance	Description	Data
N/A	Ramp Length (in)	46.5	Yes	Ramp Slope (%)	8.0
No	Ramp Width (in)	47.5	Yes	Ramp XSlope (%)	1.1
N/A	Flare Type LT	N/A	N/A	Flare Type RT	N/A
N/A	Flare Slope LT (%)	N/A	N/A	Flare Slope RT (%)	N/A
N/A	Flare Traversable LT?	N/A	N/A	Flare Traversable RT?	N/A
N/A	Landing Length (in)	N/A	N/A	DWS Provided?	N/A
N/A	Landing Width (in)	N/A	N/A	DWS Contrast?	N/A
N/A	Landing Slope (%)	N/A	N/A	DWS Length (in)	N/A
N/A	Landing X Slope (%)	N/A	N/A	DWS Full Width?	N/A
N/A	Landing Curb? (Y/N)	N/A	N/A	DWS Offset (in)	N/A
N/A	Shared Landing?	N/A			
N/A	Gutter Ponding?	N/A	N/A	Gutter Slope (%)	N/A
N/A	Gutter Lip Ht (in)	N/A	N/A	Gutter X Slope (%)	N/A
N/A	Painted X Walk1?	No	N/A	Painted X Walk2?	No
	X Walk 1 Direction	To SE		X Walk 2 Direction	To NE
N/A	X Walk 1 Width (in)	N/A	N/A	X Walk 2 Width (in)	N/A
	X Walk 1 Slope (%)	3.6		X Walk 2 Slope (%)	2.9
	X Walk 1 X Slope (%)	2.4		X Walk 2 X Slope (%)	2.3

N/A	Ramp inside XWalk1?	N/A	N/A	Ramp inside XWalk2?	N/A
	Road Slope (%)	1.3	N/A	Clear Space?	N/A
	Road X Slope (%)	4.3	N/A	Clear Space to XWalk (in)	N/A
N/A	Any Obstructions?	N/A	N/A	Storm Grate/Utility Hazard?	N/A
	Obstruction Type			Storm Grate/Utility Type	
		N/A			N/A
			Yes	Surface Condition? (G/P)	Good

Remove & Replace Curb Ramp With Two New Directional Ramps or Equivalent.
