# Access Compliance Report

## Public Rights-of-Way

### (Curb Ramps)

Intersection ID: 8714	Main Street: LASALLE_ST	Cross Street: CELIA_AV	Location:	N
ADA ID: 31763D40E6A0	Ramp Type: Perp	Initial Pass/Fail: Fail	Overall Compliance: No	Severity Score: 13.75

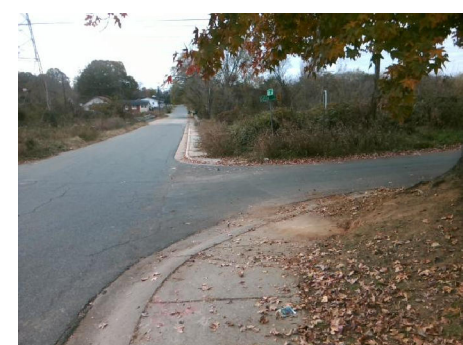
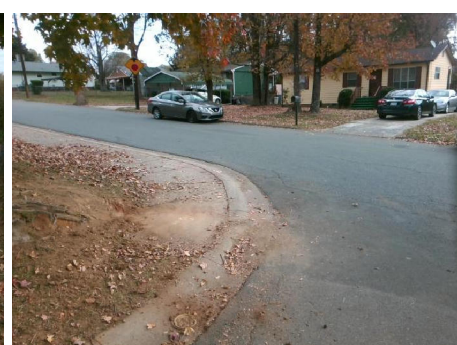
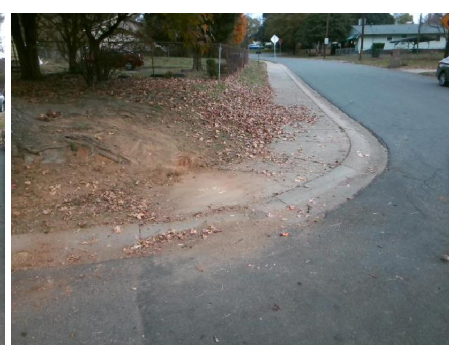
Possible Solutions:		<b>Compliance</b>	<b>Description</b>	<b>Data</b>
	Remove & Replace Entire Ramp.		N/A	Ramp Length (in)	59.5
			Yes	Ramp Width (in)	87.0
			N/A	Flare Type LT	N/A
			N/A	Flare Slope LT (%)	N/A
			N/A	Flare Traversable LT?	N/A
			N/A	Landing Length (in)	N/A
			N/A	Landing Width (in)	N/A
			N/A	Landing Slope (%)	N/A
			N/A	Landing X Slope (%)	N/A
<p>Surveyor Notes:</p> <p>N/A</p> <p>PROW/ADA:</p> <p>Not Found, R304.2.2, R304.5.3</p>			N/A	Flare Type RT	N/A
			N/A	Flare Slope RT (%)	N/A
			N/A	Flare Traversable RT?	N/A
			N/A	DWS Provided?	N/A
			N/A	DWS Contrast?	N/A
			N/A	DWS Length (in)	N/A
			N/A	DWS Full Width?	N/A
			N/A	DWS Offset (in)	N/A
			N/A	Shared Landing?	N/A
			N/A	Gutter Ponding?	Yes
			N/A	Gutter Lip Ht (in)	N/A
			N/A	Painted X Walk1?	No
				X Walk 1 Direction	To SW
			N/A	X Walk 1 Width (in)	N/A

X Walk 1 Slope (%)	2.1
				X Walk 1 X Slope (%)	2.4
			N/A	Ramp inside XWalk1?	N/A
			N/A	Road Slope (%)	N/A
			N/A	Road X Slope (%)	N/A
			N/A	Any Obstructions?	N/A
				Obstruction Type	
Total Cost:		\$ 1850.00			
			N/A		N/A
			Yes	Surface Condition? (G/P)	Good
