# Access Compliance Report

## Public Rights-of-Way

### (Curb Ramps)

Intersection ID: 3071	Main Street: BLACK_MAPLE_AV	Cross Street: NORWAY_CT	Location:	N
ADA ID: 32B8FF9DC4AD	Ramp Type: Perp	Initial Pass/Fail: Fail	Overall Compliance: No	Severity Score: 10

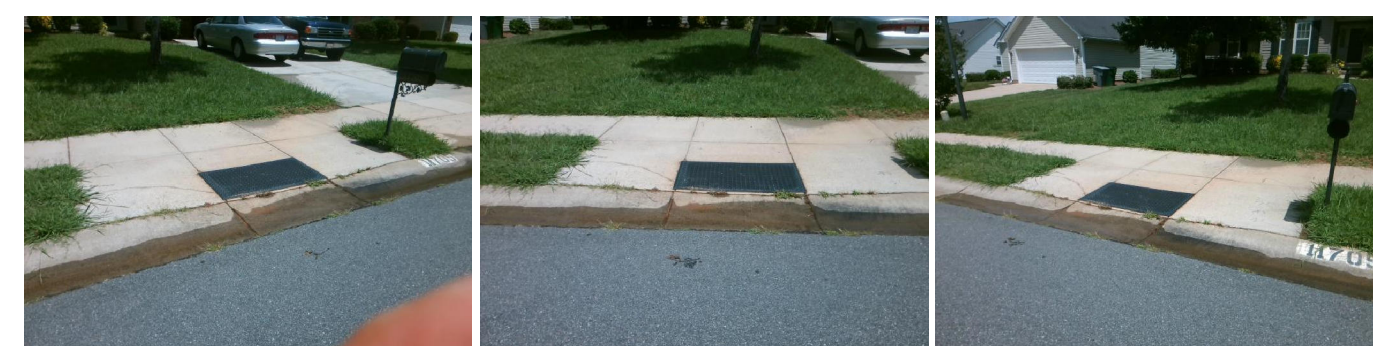
<b>N/A</b>	Gutter Lip Ht (in)	<b>N/A</b>	<b>N/A</b>
			<b>N/A</b>	Painted X Walk1?	<b>No</b>	<b>N/A</b>
				X Walk 1 Direction	<b>To S</b>	
			<b>N/A</b>	X Walk 1 Width (in)	<b>N/A</b>	<b>N/A</b>
				X Walk 1 Slope (%)	<b>6.0</b>	
				X Walk 1 X Slope (%)	<b>3.0</b>	
			<b>N/A</b>	Ramp inside XWalk1?	<b>N/A</b>	<b>N/A</b>
<p>Street 1 Name</p> <p>Stop Condition-Street 2</p> <p>Street 2 Name</p> <p>Stop Condition-Street 1</p>			<b>N/A</b>	Road Slope (%)	<b>N/A</b>	<b>N/A</b>
				Road X Slope (%)	<b>N/A</b>	<b>N/A</b>
			<b>N/A</b>	Any Obstructions?	<b>N/A</b>	<b>N/A</b>
				Obstruction Type		
Total Cost:		\$ 1850.00				
			<b>N/A</b>			<b>N/A</b>
			<b>Yes</b>	Surface Condition? (G/P)		<b>Good</b>

Possible Solutions:		<b>Compliance</b>	<b>Description</b>	<b>Data</b>	
	<b>Remove &amp; Replace Entire Ramp.</b>		<b>N/A</b>	Ramp Length (in)	<b>50.5</b>	<b>Yes</b>
			<b>No</b>	Ramp Width (in)	<b>46.0</b>	<b>Yes</b>
			<b>N/A</b>	Flare Type LT	<b>N/A</b>	<b>N/A</b>
			<b>N/A</b>	Flare Slope LT (%)	<b>N/A</b>	<b>N/A</b>
			<b>N/A</b>	Flare Traversable LT?	<b>N/A</b>	<b>N/A</b>
			<b>N/A</b>	Landing Length (in)	<b>N/A</b>	<b>N/A</b>
			<b>N/A</b>	Landing Width (in)	<b>N/A</b>	<b>N/A</b>
			<b>N/A</b>	Landing Slope (%)	<b>N/A</b>	<b>N/A</b>
			<b>N/A</b>	Landing X Slope (%)	<b>N/A</b>	<b>N/A</b>
<p>Surveyor Notes:</p> <p><b>N/A</b></p> <p>PROW/ADA:</p> <p><b>Not Found, R304.5.1</b></p>			<b>N/A</b>	Landing Curb? (Y/N)	<b>N/A</b>	<b>N/A</b>
			<b>N/A</b>	Shared Landing?	<b>N/A</b>	
			<b>N/A</b>	Gutter Ponding?	<b>Yes</b>	<b>N/A</b>
