Access Compliance Report

Public Rights-of-Way

(Curb Ramps)

Intersection ID: 8512	Main Street: ISENHOUR_ST	Cross Street: MCARTHUR_AV	Location: SW
ADA ID: 338DEE0B304C	Ramp Type: Perp	Initial Pass/Fail: Fail	Overall Compliance: No
		Severity Score: 35

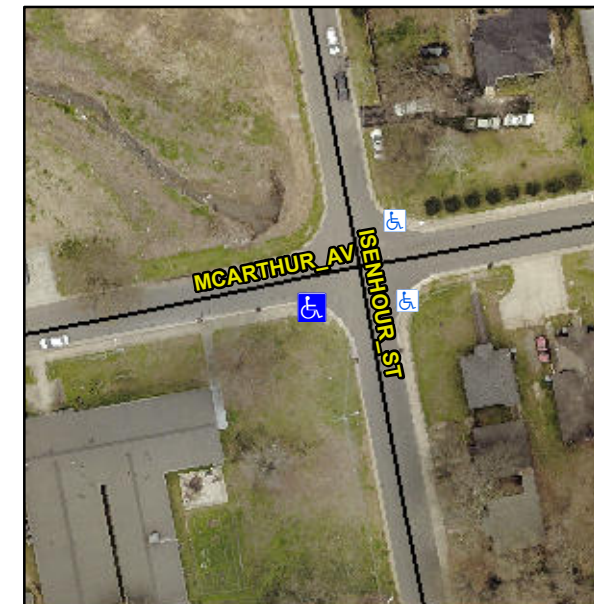
Not Found, R304.5.1, R304.2.2, R304.5.3

Compliance	Description	Data	Compliance	Description	Data
N/A	Ramp Length (in)	60.5	No	Ramp Slope (%)	13.4
No	Ramp Width (in)	37.0	No	Ramp XSlope (%)	3.2
N/A	Flare Type LT	N/A	N/A	Flare Type RT	N/A
N/A	Flare Slope LT (%)	N/A	N/A	Flare Slope RT (%)	N/A
N/A	Flare Traversable LT?	N/A	N/A	Flare Traversable RT?	N/A
N/A	Landing Length (in)	N/A	N/A	DWS Provided?	N/A
N/A	Landing Width (in)	N/A	N/A	DWS Contrast?	N/A
N/A	Landing Slope (%)	N/A	N/A	DWS Length (in)	N/A
N/A	Landing X Slope (%)	N/A	N/A	DWS Full Width?	N/A
N/A	Landing Curb? (Y/N)	N/A	N/A	DWS Offset (in)	N/A
N/A	Shared Landing?	N/A			
N/A	Gutter Ponding?	N/A	N/A	Gutter Slope (%)	N/A
N/A	Gutter Lip Ht (in)	N/A	N/A	Gutter X Slope (%)	N/A
N/A	Painted X Walk1?	No	N/A	Painted X Walk2?	N/A
	X Walk 1 Direction	To E		X Walk 2 Direction	N/A
N/A	X Walk 1 Width (in)	N/A	N/A	X Walk 2 Width (in)	N/A
	X Walk 1 Slope (%)	2.8		X Walk 2 Slope (%)	N/A
	X Walk 1 X Slope (%)	1.0		X Walk 2 X Slope (%)	N/A

Remove & Replace Entire Ramp.
