# Access Compliance Report

## Public Rights-of-Way (Curb Ramps)

| Intersection ID: 31304 | Main Street: WESTBEND_DR | Cross Street: ALEXANDER_POINTE_DR | Location: SW |
| ADA ID: 33A358B2A23D | Ramp Type: PerpDiag | Initial Pass/Fail: Fail | Overall Compliance: No |

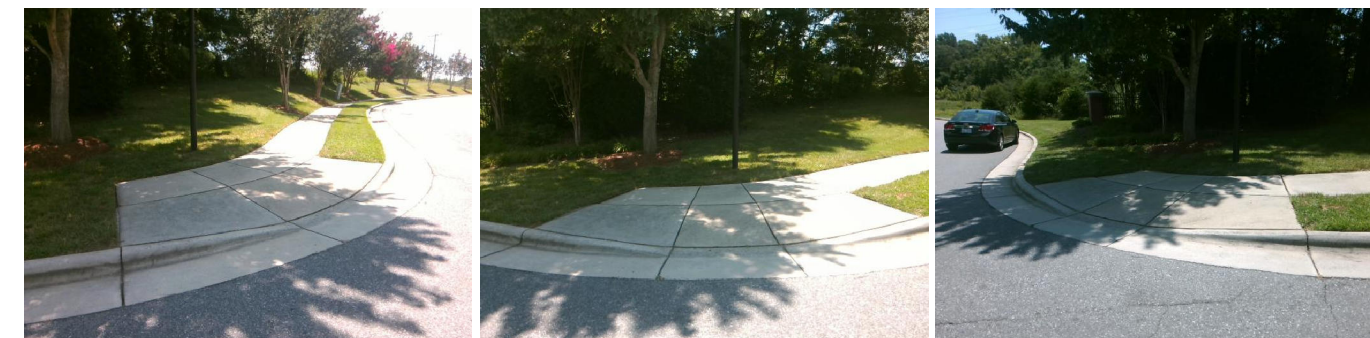
| Severity Score: 58.75 | | | |

**R304.5.1, R304.2.2, R304.5.3**

| Compliance | Description | Data | Compliance | Description | Data |
|---|---|---|---|---|---|
| N/A | Ramp Length (in) | 48.0 | No | Ramp Slope (%) | 14.8 |
| No | Ramp Width (in) | 39.0 | No | Ramp XSlope (%) | 9.1 |

**Remove & Replace Curb Ramp With Two New Directional Ramps or Equivalent.**
