Access Compliance Report

Public Rights-of-Way

(Curb Ramps)

| Intersection ID: 3373 | Main Street: KATELYN_DR | Cross Street: PROSPERITY_CHURCH_RD | Location: E |

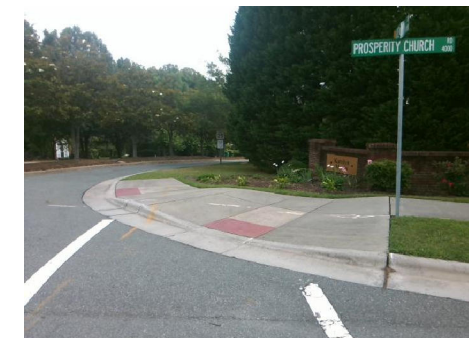
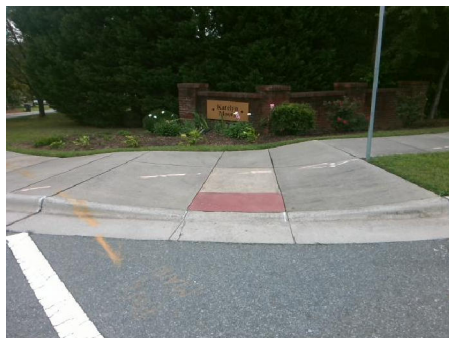
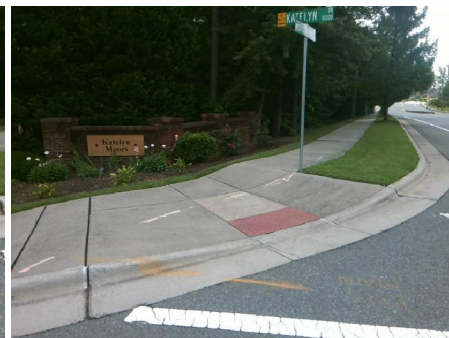
LT RP < 5%

R304.3.2

| Compliance | Description | Data | Compliance | Description | Data |
|---|---|---|---|---|---|
| Yes | Ramp Slope LT (%) | 3.5 | No | Ramp Slope RT (%) | 12.5 |

Remove & Replace Entire Ramp.
