# Access Compliance Report

## Public Rights-of-Way

### (Curb Ramps)

| Intersection ID: 4147 | Main Street: DAVIS_LAKE_PY | Cross Street: SAGEWOOD_PL | Location: NE |

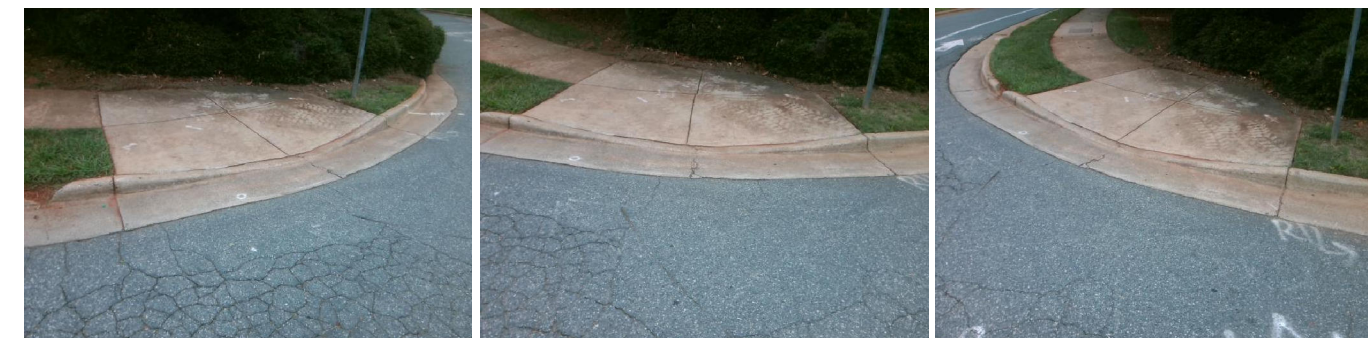
| ADA ID: 34F876363544 | Ramp Type: Perp | Initial Pass/Fail: Fail | Overall Compliance: No |

| Compliance | Description | Data | Compliance | Description | Data |
|---|---|---|---|---|---|
| N/A | Ramp Length (in) | 48.0 | No | Ramp Slope (%) | 20.0 |
| Yes | Ramp Width (in) | 51.0 | No | Ramp XSlope (%) | 10.0 |

**Remove & Replace Entire Ramp.**
