# Access Compliance Report

## Public Rights-of-Way

### (Curb Ramps)

| Intersection ID: 52457 | Main Street: ORCHARD_LAKE_DR | Cross Street: LUCY_JANE_LN | Location: S |

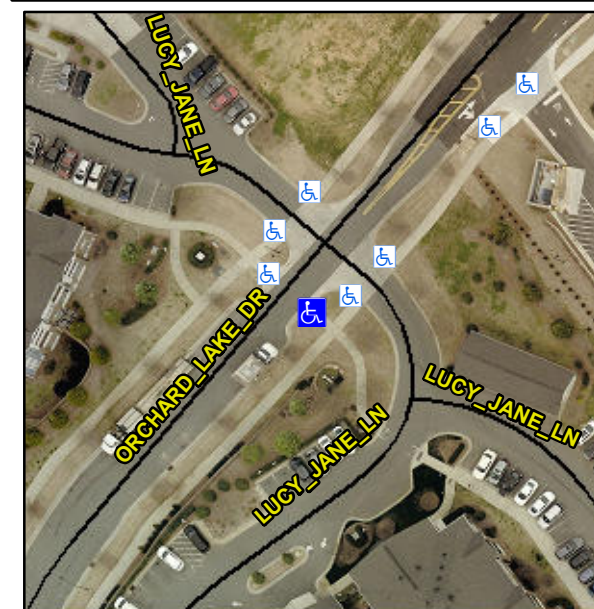
| ADA ID: 356DA5660BF4 | Ramp Type: BlendTrans1 | Initial Pass/Fail: Pass | Overall Compliance: No |

**Not Found, R304.2.2-Perp, R304.3.2-Para**

| Compliance | Description | Data | Compliance | Description | Data |
|---|---|---|---|---|---|
| No | Landing Slope (%) | 2.7 | Yes | DWS Length (in) | 24.0 |

**Remove & Replace Curb Ramp With Two New Directional Ramps or Equivalent.**
