# Access Compliance Report

## Public Rights-of-Way

### (Curb Ramps)

Intersection ID: 10021134	Main Street: BEVINGTON_PL	Cross Street: N/A	Location: S
ADA ID: 3687FACE1EAA	Ramp Type: Perp	Initial Pass/Fail: Fail	Overall Compliance: No
			Severity Score: 13.75

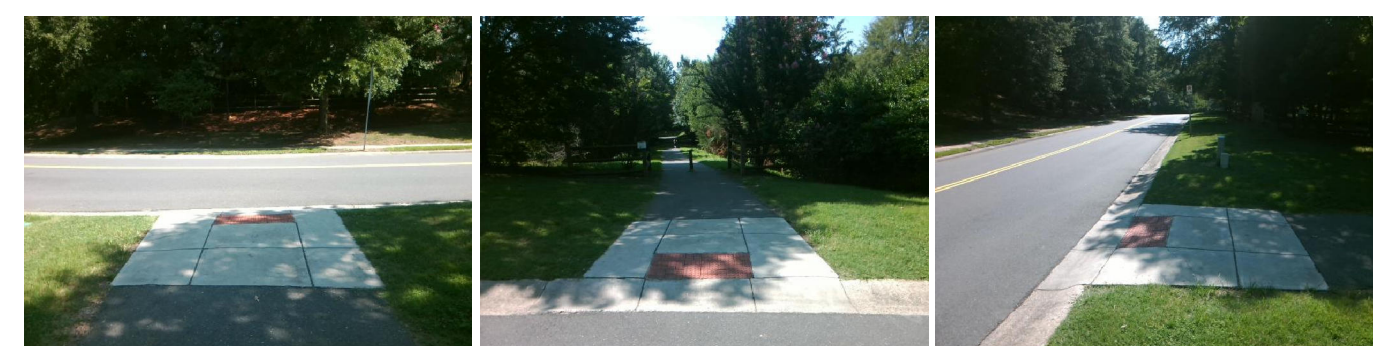
Possible Solutions:		<b>Compliance</b>	<b>Description</b>	<b>Data</b>
	Remove & Replace Entire Ramp.		N/A	Ramp Length (in)	24.0
			Yes	Ramp Width (in)	48.0
			N/A	Flare Type LT	N/A
			N/A	Flare Slope LT (%)	N/A
			N/A	Flare Traversable LT?	N/A
			N/A	Landing Length (in)	N/A
			N/A	Landing Width (in)	N/A
			N/A	Landing Slope (%)	N/A
			N/A	Landing X Slope (%)	N/A
			N/A	Landing Curb? (Y/N)	N/A
			N/A	Shared Landing?	N/A
			N/A	Gutter Ponding?	N/A
			N/A	Gutter Lip Ht (in)	N/A
			N/A	Painted X Walk1?	No
				X Walk 1 Direction	To N
			N/A	X Walk 1 Width (in)	N/A
				X Walk 1 Slope (%)	4.7
				X Walk 1 X Slope (%)	3.7
			N/A	Ramp inside XWalk1?	N/A
<p>Surveyor Notes:</p> <p>N/A</p> <p>PROW/ADA:</p> <p>R304.2.2, R304.5.3</p>			N/A	Ramp Slope (%)	9.1
			No	Ramp XSlope (%)	4.8
			N/A	Flare Type RT	N/A
			N/A	Flare Slope RT (%)	N/A
			N/A	Flare Traversable RT?	N/A

N/A	DWS Provided?	N/A
			N/A	DWS Contrast?	N/A
			N/A	DWS Length (in)	N/A
			N/A	DWS Full Width?	N/A
			N/A	DWS Offset (in)	N/A
			N/A	Gutter Slope (%)	N/A
			N/A	Gutter X Slope (%)	N/A
			N/A	Painted X Walk2?	N/A
				X Walk 2 Direction	N/A
			N/A	X Walk 2 Width (in)	N/A
				X Walk 2 Slope (%)	N/A
				X Walk 2 X Slope (%)	N/A
			N/A	Ramp inside XWalk2?	N/A
			N/A	Clear Space?	N/A
			N/A	Clear Space to XWalk (in)	N/A
<p>Total Cost:</p> <p>\$ 1850.00</p>			N/A	Storm Grate/Utility Hazard?	N/A
				Storm Grate/Utility Type	N/A
			N/A		N/A
			Yes	Surface Condition? (G/P)	Good
