# Access Compliance Report

## Public Rights-of-Way

### (Curb Ramps)

Intersection ID: 7528	Main Street: LEMS福德_WY	Cross Street: SILCHESTER_LN	Location:	E
ADA ID: 36C33C845073	Ramp Type: Directional1	Initial Pass/Fail: Fail	Overall Compliance: No	Severity Score: 12.5

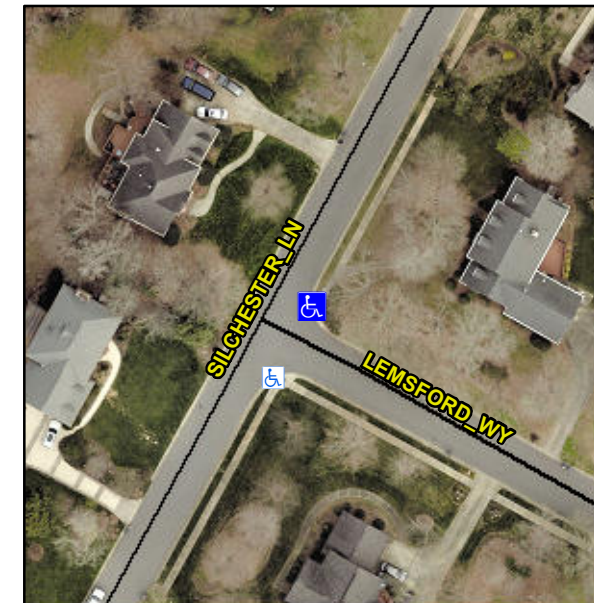
Compliance	Description	Data	Compliance	Description	Data
N/A	Ramp Length (in)	114.5	N/A	Grade Break?	N/A
Yes	Ramp Width (in)	48.0	N/A	Grade Break Slope (%)	0.0
Yes	Ramp Slope (%)	7.1	N/A	Grade Break XSlope (%)	0.0
No	Ramp XSlope (%)	6.7			
N/A	Flare Type LT	N/A	N/A	Flare Type RT	N/A
N/A	Flare Slope LT (%)	N/A	N/A	Flare Slope RT (%)	0.0
N/A	Flare Traversable LT?	N/A	N/A	Flare Traversable RT?	N/A
N/A	Landing Length (in)	0.0	N/A	DWS Provided?	N/A
N/A	Landing Width (in)	0.0	N/A	DWS Contrast?	N/A
N/A	Landing Slope (%)	0.0	N/A	DWS Length (in)	N/A
N/A	Landing X Slope (%)	0.0	N/A	DWS Full Width?	N/A
N/A	Landing Curb? (Y/N)	N/A	N/A	DWS Offset LT (in)	N/A
N/A	Shared Landing?	N/A	N/A	DWS Offset RT (in)	N/A
N/A	Gutter Ponding?	0.0	N/A	Gutter Slope (%)	N/A
N/A	Gutter Lip Ht (in)	0.0	N/A	Gutter X Slope (%)	N/A
N/A	Painted X Walk1?	No		Road Slope (%)	2.5
	X Walk 1 Direction	To SW		Road X Slope (%)	3.3
	X Walk 1 Width (in)	N/A		Clear Space?	N/A

X Walk 1 Slope (%)	2.5	N/A	Clear Space to XWalk (in)	N/A
	X Walk 1 X Slope (%)	3.3	N/A	Storm Grate/Utility Hazard?	N/A
N/A	Ramp inside XWalk1?	N/A		Storm Grate/Utility Type	
N/A	Any Obstructions?	N/A			N/A
	Obstruction Type		Yes	Surface Condition? (G/P)	Good
			N/A	Curb Slope (%)	9.0

**Remove & Replace Entire Ramp.**
