Access Compliance Report

Public Rights-of-Way

(Curb Ramps)

Intersection ID: 7034	Main Street: GRAHAM_MEADOW_DR	Cross Street: PESCA_LN	Location: W
ADA ID: 37D1BB6F7328	Ramp Type: Directional1	Initial Pass/Fail: Pass	Overall Compliance: No
Severity Score: 0			
Codes/Mitigation Info/Possible Solution		Field Measurements/Component Compliance

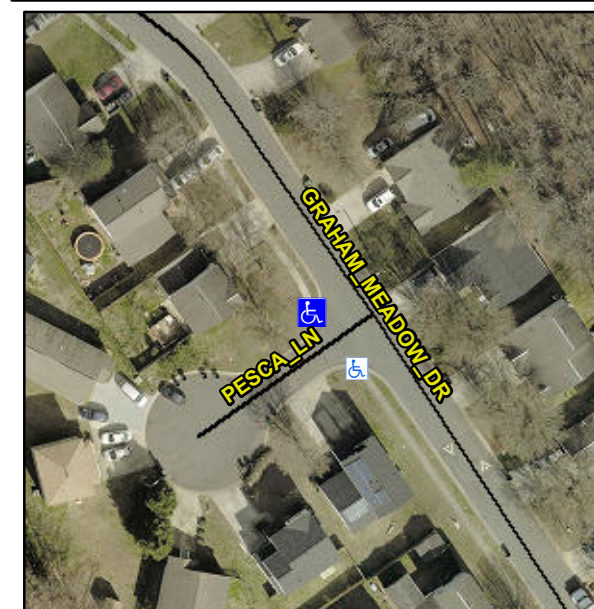
Not Found, R304.5.3

Compliance	Description	Data	Compliance	Description	Data
N/A	Ramp Length (in)	24.0	Yes	Grade Break?	Yes
Yes	Ramp Width (in)	48.0	Yes	Grade Break Slope (%)	0.2
Yes	Ramp Slope (%)	0.5	Yes	Grade Break XSlope (%)	0.1
Yes	Ramp XSlope (%)	0.5			
N/A	Flare Type LT	N/A	N/A	Flare Type RT	N/A
N/A	Flare Slope LT (%)	N/A	N/A	Flare Slope RT (%)	N/A
N/A	Flare Traversable LT?	N/A	N/A	Flare Traversable RT?	N/A
Yes	Landing Length (in)	62.5	Yes	DWS Provided?	Yes
Yes	Landing Width (in)	48.0	Yes	DWS Contrast?	Yes
Yes	Landing Slope (%)	0.1	Yes	DWS Length (in)	24.0
No	Landing X Slope (%)	2.7	Yes	DWS Full Width?	Yes
N/A	Landing Curb? (Y/N)	No	Yes	DWS Offset LT (in)	52.0
N/A	Shared Landing?	No	Yes	DWS Offset RT (in)	2.0
Yes	Gutter Ponding?	No	Yes	Gutter Slope (%)	1.6
Yes	Gutter Lip Ht (in)	0.0	Yes	Gutter X Slope (%)	0.9
N/A	Painted X Walk1?	No		Road Slope (%)	5.7
	X Walk 1 Direction	To SE		Road X Slope (%)	3.4
	X Walk 1 Width (in)	N/A		Clear Space?	Yes

X Walk 1 Slope (%)	5.7	N/A	Clear Space to XWalk (in)	N/A
	X Walk 1 X Slope (%)	3.4	Yes	Storm Grate/Utility Hazard?	No
N/A	Ramp inside XWalk1?	N/A		Storm Grate/Utility Type	
Yes	Any Obstructions?	No			N/A
	Obstruction Type		Yes	Surface Condition? (G/P)	Good
			N/A	Curb Slope (%)	17.2

Remove & Replace Entire Ramp.
