Access Compliance Report

Public Rights-of-Way

(Curb Ramps)

Intersection ID: 8521	Main Street: HILDEBRAND_ST	Cross Street: MARIBEL_AV	Location: NW
ADA ID: 38026B374861	Ramp Type: Perp	Initial Pass/Fail: Fail	Overall Compliance: No
Codes/Mitigation Info/Possible Solution		Field Measurements/Component Compliance	
Severity Score: 22.5

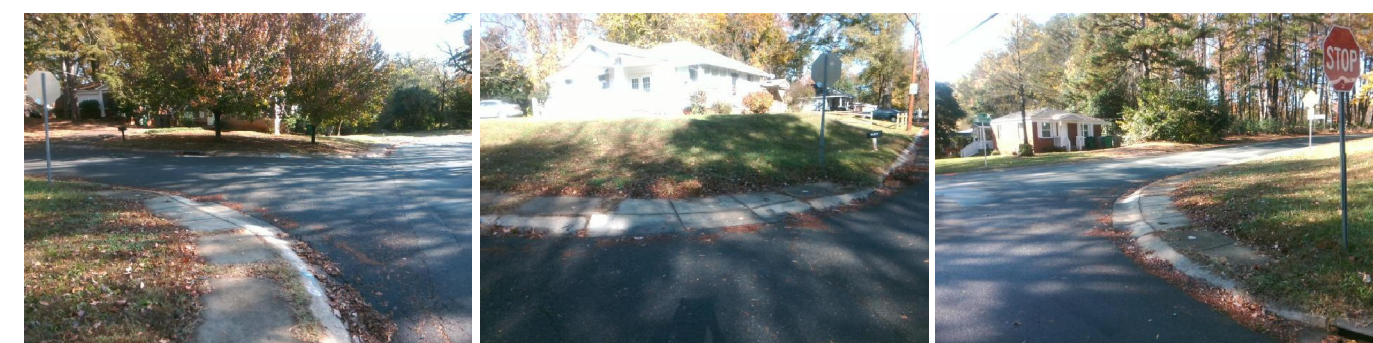
Possible Solutions:						
	Remove & Replace Entire Ramp.						
	Surveyor Notes:						
	N/A						
	PROW/ADA:						
	Not Found, R304.5.1, R304.2.2, R304.5.3						
	Street 1 Name	MARIBEL AV					
	Stop Condition-Street 2	StopSign					
	Street 2 Name	N/A					
	Stop Condition-Street 1	N/A					
Total Cost:		\$ 1850.00					
				Compliance	Description	Data	Compliance
				Description			Description
				Data			Data
				N/A	Ramp Length (in)	48.0	No
				No	Ramp Width (in)	46.0	No
				N/A	Flare Type LT	N/A	N/A
				N/A	Flare Slope LT (%)	N/A	N/A
				N/A	Flare Traversable LT?	N/A	N/A
				N/A	Landing Length (in)	N/A	N/A
				N/A	Landing Width (in)	N/A	N/A
				N/A	Landing Slope (%)	N/A	N/A
				N/A	Landing X Slope (%)	N/A	N/A
				N/A	Landing Curb? (Y/N)	N/A	N/A
				N/A	Shared Landing?	N/A	
				N/A	Gutter Ponding?	N/A	N/A
				N/A	Gutter Lip Ht (in)	N/A	N/A
				N/A	Painted X Walk1?	No	N/A
					X Walk 1 Direction	To E	
				N/A	X Walk 1 Width (in)	N/A	N/A

X Walk 1 Slope (%)	4.1	
					X Walk 1 X Slope (%)	1.0	
				N/A	Ramp inside XWalk1?	N/A	N/A
					Road Slope (%)	N/A	N/A
					Road X Slope (%)	N/A	N/A
				N/A	Any Obstructions?	N/A	N/A
					Obstruction Type		
						N/A	N/A
						Yes	Surface Condition? (G/P)
							Good
