# Access Compliance Report

## Public Rights-of-Way

### (Curb Ramps)

| Intersection ID: 24623 | Main Street: CARMEL_RD | Cross Street: WINDWOOD_CR | Location: W |

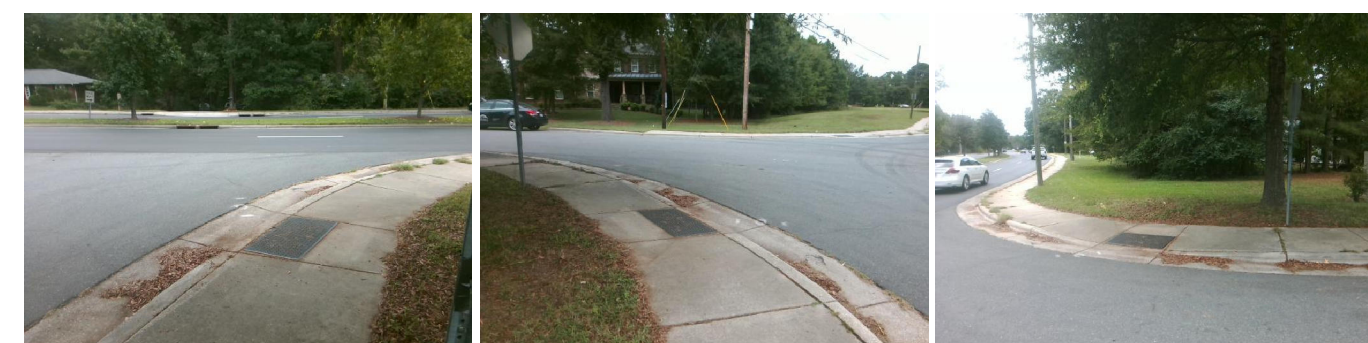
| ADA ID: 3843C1927D35 | Ramp Type: PerpDiag | Initial Pass/Fail: Fail | Overall Compliance: No |

**Not Found, R304.5.1, R304.2.2, R304.5.3**

| Compliance | Description | Data | Compliance | Description | Data |
|---|---|---|---|---|---|
| N/A | Ramp Length (in) | 60.0 | No | Ramp Slope (%) | 9.2 |
| No | Ramp Width (in) | 45.0 | No | Ramp XSlope (%) | 3.6 |

**Remove & Replace Curb Ramp With Two New Directional Ramps or Equivalent.**
