# Access Compliance Report

## Public Rights-of-Way

### (Curb Ramps)

Intersection ID: 50747	Main Street: MONTELENA_DR	Cross Street: ARTESA_CT	Location:	NE
ADA ID: 3877174BC4FA	Ramp Type: Perp	Initial Pass/Fail: Fail	Overall Compliance: No	Severity Score: 8.75

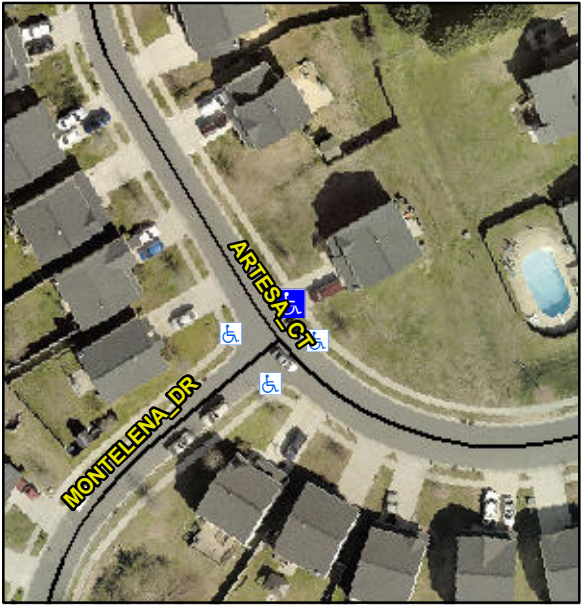
Possible Solutions:		<b>Compliance</b>	<b>Description</b>	<b>Data</b>
	<b>Remove &amp; Replace Entire Ramp.</b>		<b>Yes</b>	Ramp Length (in)	5.8
			<b>No</b>	Ramp Width (in)	0.2
			<b>N/A</b>	Flare Type LT	N/A
			<b>N/A</b>	Flare Slope LT (%)	N/A
			<b>N/A</b>	Flare Traversable LT?	N/A
			<b>N/A</b>	Landing Length (in)	N/A
			<b>N/A</b>	Landing Width (in)	N/A
			<b>N/A</b>	Landing Slope (%)	N/A
			<b>N/A</b>	Landing X Slope (%)	N/A
<p>Surveyor Notes:</p> <p><b>N/A</b></p> <p>PROW/ADA:</p> <p><b>Not Found, R304.5.1</b></p>			<b>N/A</b>	Flare Type RT	N/A
			<b>N/A</b>	Flare Slope RT (%)	N/A
			<b>N/A</b>	Flare Traversable RT?	N/A
			<b>N/A</b>	DWS Provided?	N/A
			<b>N/A</b>	DWS Contrast?	N/A
			<b>N/A</b>	DWS Length (in)	N/A
			<b>N/A</b>	DWS Full Width?	N/A
			<b>N/A</b>	DWS Offset (in)	N/A
			<b>N/A</b>	Shared Landing?	N/A

<b>N/A</b>	Gutter Ponding?	N/A
			<b>N/A</b>	Gutter Lip Ht (in)	N/A
			<b>N/A</b>	Painted X Walk1?	N/A
			<b>No</b>	Painted X Walk2?	N/A
			<b>To W</b>	X Walk 1 Direction	N/A
			<b>N/A</b>	X Walk 1 Width (in)	N/A
			<b>3.3</b>	X Walk 1 Slope (%)	N/A
			<b>2.6</b>	X Walk 1 X Slope (%)	N/A
			<b>N/A</b>	Ramp inside XWalk1?	N/A
			<b>N/A</b>	Ramp inside XWalk2?	N/A
			<b>N/A</b>	Road Slope (%)	N/A
			<b>N/A</b>	Road X Slope (%)	N/A
			<b>N/A</b>	Any Obstructions?	N/A
			<b>N/A</b>	Obstruction Type	N/A
			<b>N/A</b>	Clear Space?	N/A
			<b>N/A</b>	Clear Space to XWalk (in)	N/A
			<b>N/A</b>	Storm Grate/Utility Hazard?	N/A
			<b>N/A</b>	Storm Grate/Utility Type	N/A
			<b>N/A</b>	Surface Condition? (G/P)	Good
			<b>Yes</b>

Total Cost: \$ 1850.00
