Access Compliance Report

Public Rights-of-Way

(Curb Ramps)

Intersection ID: 25287	Main Street: CEDAR_POINT_LN	Cross Street: JOHNSTON_RD	Location: SW
ADA ID: 38B1E429A6DF	Ramp Type: Perp	Initial Pass/Fail: Fail	Overall Compliance: No
Severity Score: 12.5			
Codes/Mitigation Info/Possible Solution		Field Measurements/Component Compliance

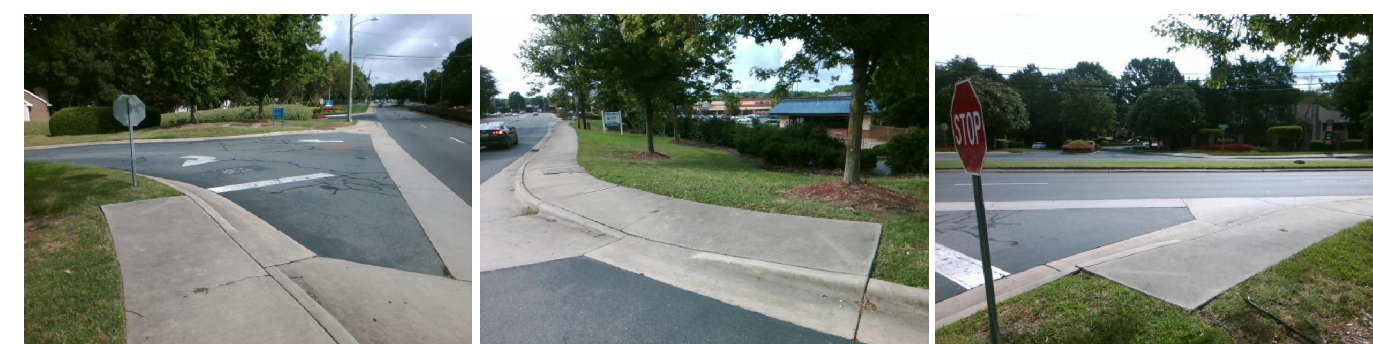
Compliance	Description	Data	Compliance	Description	Data
N/A	Ramp Length (in)	59.0	No	Ramp Slope (%)	8.8
Yes	Ramp Width (in)	48.0	Yes	Ramp XSlope (%)	1.2
N/A	Flare Type LT	N/A	N/A	Flare Type RT	N/A
N/A	Flare Slope LT (%)	N/A	N/A	Flare Slope RT (%)	N/A
N/A	Flare Traversable LT?	N/A	N/A	Flare Traversable RT?	N/A
N/A	Landing Length (in)	N/A	N/A	DWS Provided?	N/A
N/A	Landing Width (in)	N/A	N/A	DWS Contrast?	N/A
N/A	Landing Slope (%)	N/A	N/A	DWS Length (in)	N/A
N/A	Landing X Slope (%)	N/A	N/A	DWS Full Width?	N/A
N/A	Landing Curb? (Y/N)	N/A	N/A	DWS Offset (in)	N/A
N/A	Shared Landing?	N/A			
N/A	Gutter Ponding?	N/A	N/A	Gutter Slope (%)	N/A
N/A	Gutter Lip Ht (in)	N/A	N/A	Gutter X Slope (%)	N/A
N/A	Painted X Walk1?	No	N/A	Painted X Walk2?	N/A
	X Walk 1 Direction	To NW		X Walk 2 Direction	N/A
N/A	X Walk 1 Width (in)	N/A	N/A	X Walk 2 Width (in)	N/A
	X Walk 1 Slope (%)	0.2		X Walk 2 Slope (%)	N/A
	X Walk 1 X Slope (%)	1.8		X Walk 2 X Slope (%)	N/A

Remove & Replace Entire Ramp.
