Intersection ID: 29432	Main Street: MIRTH_LN	Cross Street: PALESTRINA_RD	Location:	SW
ADA ID: 3959A2CA0D96	Ramp Type: Perp	Initial Pass/Fail: Fail	Overall Compliance: No	Severity Score: 21.25

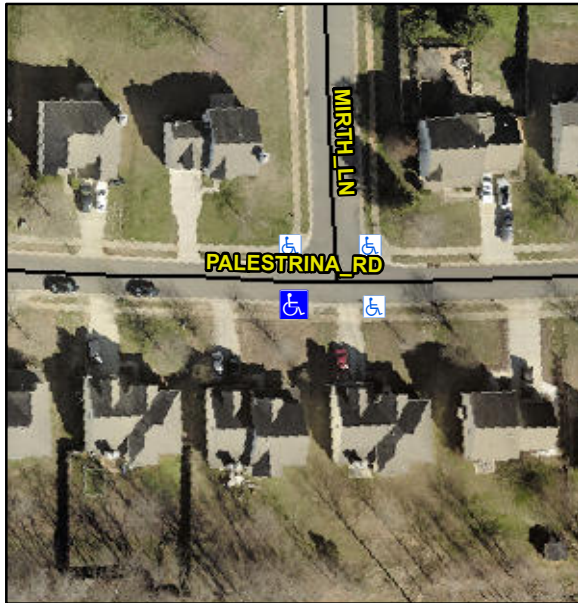
**Not Found, R304.5.1, R304.2.2**

Possible Solutions:			Compliance	Description	Data	Compliance	Description	Data		
<b>Remove &amp; Replace Entire Ramp.</b>			N/A	Ramp Length (in)	47.0	No	Ramp Slope (%)	9.0		
			No	Ramp Width (in)	47.5	Yes	Ramp XSlope (%)	1.4		
			N/A	Flare Type LT	N/A	N/A	Flare Type RT	N/A		
			N/A	Flare Slope LT (%)	N/A	N/A	Flare Slope RT (%)	N/A		
			N/A	Flare Traversable LT?	N/A	N/A	Flare Traversable RT?	N/A		
			N/A	Landing Length (in)	N/A	N/A	DWS Provided?	N/A		
			N/A	Landing Width (in)	N/A	N/A	DWS Contrast?	N/A		
			N/A	Landing Slope (%)	N/A	N/A	DWS Length (in)	N/A		
			N/A	Landing X Slope (%)	N/A	N/A	DWS Full Width?	N/A		
			N/A	Landing Curb? (Y/N)	N/A	N/A	DWS Offset (in)	N/A		
Surveyor Notes: <b>N/A</b>			N/A	Shared Landing?	N/A					
			N/A	Gutter Ponding?	N/A	N/A	Gutter Slope (%)	N/A		
			N/A	Gutter Lip Ht (in)	N/A	N/A	Gutter X Slope (%)	N/A		
			N/A	Painted X Walk1?	No	N/A	Painted X Walk2?	N/A		
				X Walk 1 Direction	To N		X Walk 2 Direction	N/A

### Remove & Replace Entire Ramp.
