# Access Compliance Report

## Public Rights-of-Way

### (Curb Ramps)

Intersection ID: 15639	Main Street: EASTOVER_RD	Cross Street: HEMPSTEAD_PL	Location: SE
ADA ID: 39B629CA5734	Ramp Type: PerpDiag	Initial Pass/Fail: Fail	Overall Compliance: No
Codes/Mitigation Info/Possible Solution		Field Measurements/Component Compliance	
Severity Score: 50

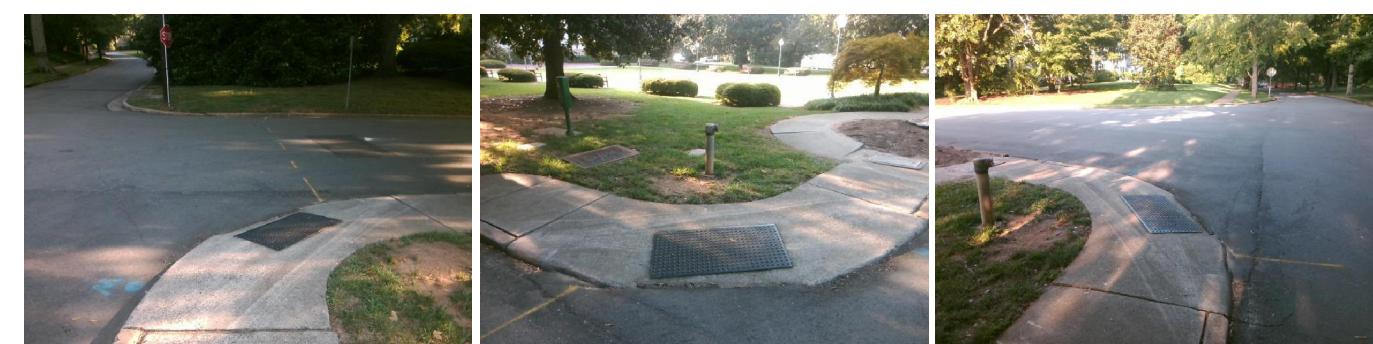
Possible Solutions:		Compliance	Description	Data	Compliance	Description	Data
	Remove & Replace Curb Ramp With Two New Directional Ramps or Equivalent.		N/A	Ramp Length (in)	52.0	No	Ramp Slope (%)	15.5
<p>Surveyor Notes:</p> <p>N/A</p> <p>PROW/ADA:</p> <p>R304.2.2, R304.5.3</p>			Yes	Ramp Width (in)	48.0	No	Ramp XSlope (%)	7.8
			N/A	Flare Type LT	N/A	N/A	Flare Type RT	N/A
<p>Street 1 Name</p> <p>Stop Condition-Street 2</p> <p>Street 2 Name</p> <p>Stop Condition-Street 1</p>			N/A	Flare Slope LT (%)	N/A	N/A	Flare Slope RT (%)	N/A
			N/A	Flare Traversable LT?	N/A	N/A	Flare Traversable RT?	N/A
<p>Total Cost:</p> <p>\$ 3200.00</p>			N/A	Landing Length (in)	N/A	N/A	DWS Provided?	N/A
			N/A	Landing Width (in)	N/A	N/A	DWS Contrast?	N/A
			N/A	Landing Slope (%)	N/A	N/A	DWS Length (in)	N/A
			N/A	Landing X Slope (%)	N/A	N/A	DWS Full Width?	N/A
			N/A	Landing Curb? (Y/N)	N/A	N/A	DWS Offset (in)	N/A
			N/A	Shared Landing?	N/A

N/A	Gutter Ponding?	N/A	N/A	Gutter Slope (%)	N/A
			N/A	Gutter Lip Ht (in)	N/A	N/A	Gutter X Slope (%)	N/A
			N/A	Painted X Walk1?	No	N/A	Painted X Walk2?	No
				X Walk 1 Direction	To N		X Walk 2 Direction	To W
			N/A	X Walk 1 Width (in)	N/A	N/A	X Walk 2 Width (in)	N/A
				X Walk 1 Slope (%)	3.5		X Walk 2 Slope (%)	6.9
				X Walk 1 X Slope (%)	5.2		X Walk 2 X Slope (%)	1.2
			N/A	Ramp inside XWalk1?	N/A	N/A	Ramp inside XWalk2?	N/A
				Road Slope (%)	5.1	N/A	Clear Space?	N/A
				Road X Slope (%)	7.5	N/A	Clear Space to XWalk (in)	N/A
			N/A	Any Obstructions?	N/A	N/A	Storm Grate/Utility Hazard?	N/A
				Obstruction Type			Storm Grate/Utility Type	
						N/A		N/A
						Yes	Surface Condition? (G/P)	Good
