Access Compliance Report

Public Rights-of-Way

(Curb Ramps)

| Intersection ID: 28105 | Main Street: ELLINGTON PARK DR | Cross Street: OLIVIA LN | Location: NE |

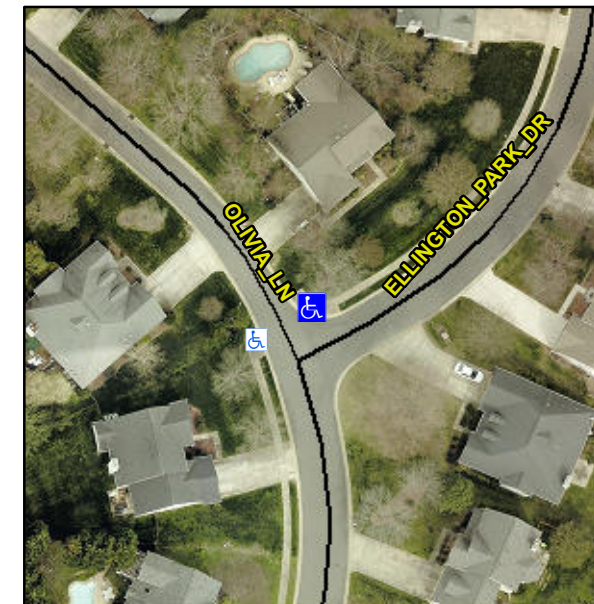
| ADA ID: 3C110C3270B5 | Ramp Type: BlendTrans2 | Initial Pass/Fail: Fail | Overall Compliance: No |

Not Found, R304.5.1

| Compliance | Description | Data | Compliance | Description | Data |
|---|---|---|---|---|---|
| No | Ramp Width (in) | 31.0 | Yes | BlendTrans XSlope (%) | 0.8 |

Remove & Replace Curb Ramp With Two New Directional Ramps or Equivalent.
