# Access Compliance Report

## Public Rights-of-Way

| Intersection ID: 30431 | Main Street: CEDAR_ROCK_DR | Cross Street: ELM_BEND_DR | Location: NE |
| ADA ID: 3CB0D8512A1C | Ramp Type: PerpDiag | Initial Pass/Fail: Fail | Overall Compliance: No |

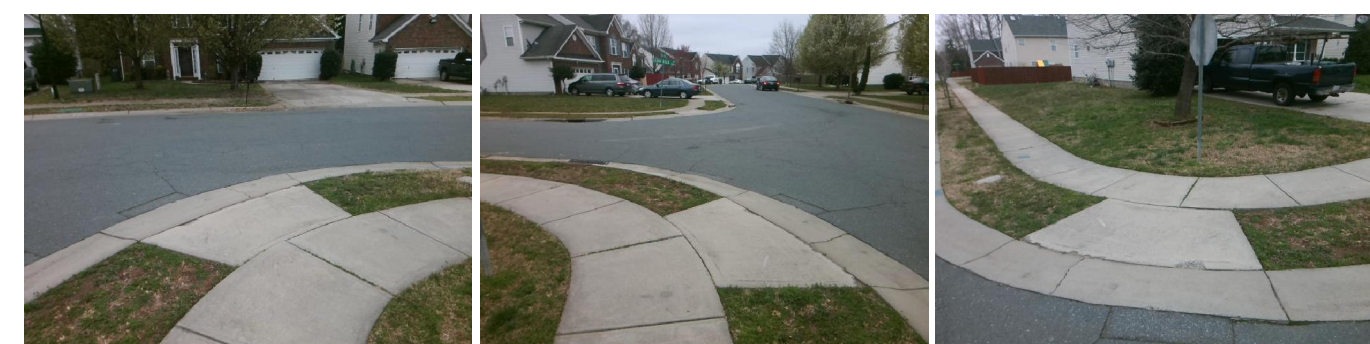
| Compliance | Description | Data | Compliance | Description | Data |
|---|---|---|---|---|---|
| N/A | Ramp Length (in) | 49.0 | No | Ramp Slope (%) | 8.9 |
| Yes | Ramp Width (in) | 48.0 | No | Ramp XSlope (%) | 2.7 |

**Remove & Replace Curb Ramp With Two New Directional Ramps or Equivalent.**
