Access Compliance Report

Public Rights-of-Way

(Curb Ramps)

Intersection ID: 27772	Main Street: BRIARWICK_LN	Cross Street: NORTH_COMMUNITY_HOUSE_RD	Location: SW
ADA ID: 3DB77FBF6448	Ramp Type: Combination1	Initial Pass/Fail: Fail	Overall Compliance: No Severity Score: 33.75

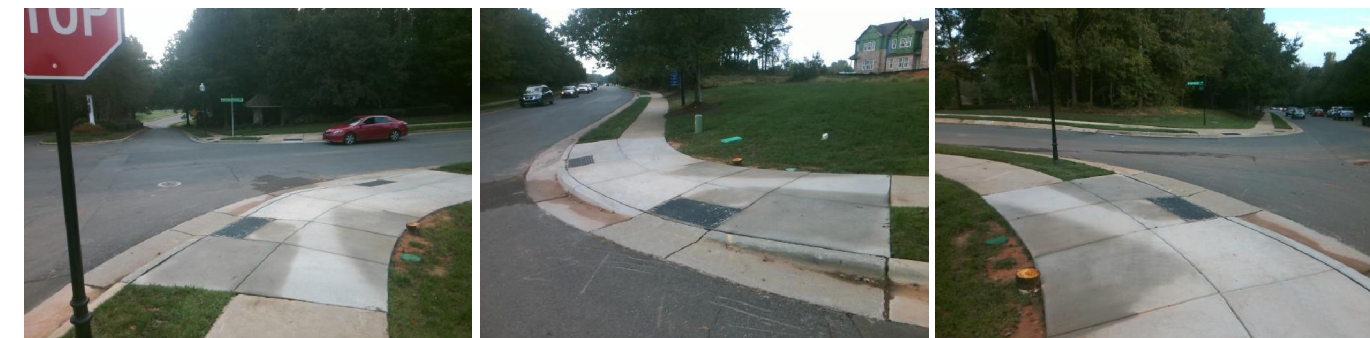
LT RP < 5%

Not Found, R304.5.1, R304.2.2, R304.5.3

Compliance	Description	Data	Compliance	Description	Data
N/A	Ramp Length LT (in)	52.0	N/A	Ramp Length RT (in)	48.0
Yes	Ramp Width LT (in)	56.0	Yes	Ramp Width RT (in)	56.0
Yes	Ramp Slope LT (%)	4.3	Yes	Ramp Slope RT (%)	8.2
Yes	Ramp XSlope LT (%)	1.4	No	Ramp XSlope RT (%)	2.5
N/A	Ramp Length (in)	52.0	No	Ramp Slope (%)	11.8
No	Ramp Width (in)	47.5	No	Ramp XSlope (%)	5.2
N/A	Flare Type LT	N/A	N/A	Flare Type RT	N/A
N/A	Flare Slope LT (%)	N/A	N/A	Flare Slope RT (%)	N/A
N/A	Flare Traversable LT?	N/A	N/A	Flare Traversable RT?	N/A
N/A	Landing Length (in)	N/A	N/A	DWS Provided?	N/A
N/A	Landing Width (in)	N/A	N/A	DWS Contrast?	N/A
N/A	Landing Slope (%)	N/A	N/A	DWS Length (in)	N/A
N/A	Landing X Slope (%)	N/A	N/A	DWS Full Width?	N/A
N/A	Landing Curb? (Y/N)	N/A	N/A	DWS Offset (in)	N/A
N/A	Shared Landing?	N/A			
N/A	Gutter Ponding?	N/A	N/A	Gutter Slope (%)	N/A
N/A	Gutter Lip Ht (in)	N/A	N/A	Gutter X Slope (%)	N/A
N/A	Painted X Walk1?	No	N/A	Painted X Walk2?	N/A

X Walk 1 Direction	To N		X Walk 2 Direction	N/A
	X Walk 1 Width (in)	N/A		X Walk 2 Width (in)	N/A
	X Walk 1 Slope (%)	3.6		X Walk 2 Slope (%)	N/A
	X Walk 1 X Slope (%)	9.2		X Walk 2 X Slope (%)	N/A
N/A	Ramp inside XWalk1?	N/A	N/A	Ramp inside XWalk2?	N/A
	Road Slope (%)	N/A		Clear Space?	N/A
	Road X Slope (%)	N/A	N/A	Clear Space to XWalk (in)	N/A
			N/A	Any Obstruction?	N/A
				Obstruction Type	N/A
			N/A	Storm Grate/Utility Hazard?	N/A
				Storm Grate/Utility Type	N/A
			Yes	Surface Condition? (G/P)	Good
				Curb Slope (%)	20.0

Remove & Replace Entire Ramp.
