Access Compliance Report

Public Rights-of-Way

(Curb Ramps)

Intersection ID: 27738	Main Street: JAMES JACK LN	Cross Street: VILLALONGA LN	Location: W
ADA ID: 3E71342235D9	Ramp Type: PerpDiag	Initial Pass/Fail: Fail	Overall Compliance: No
Codes/Mitigation Info/Possible Solution			Severity Score: 17.5
			Field Measurements/Component Compliance

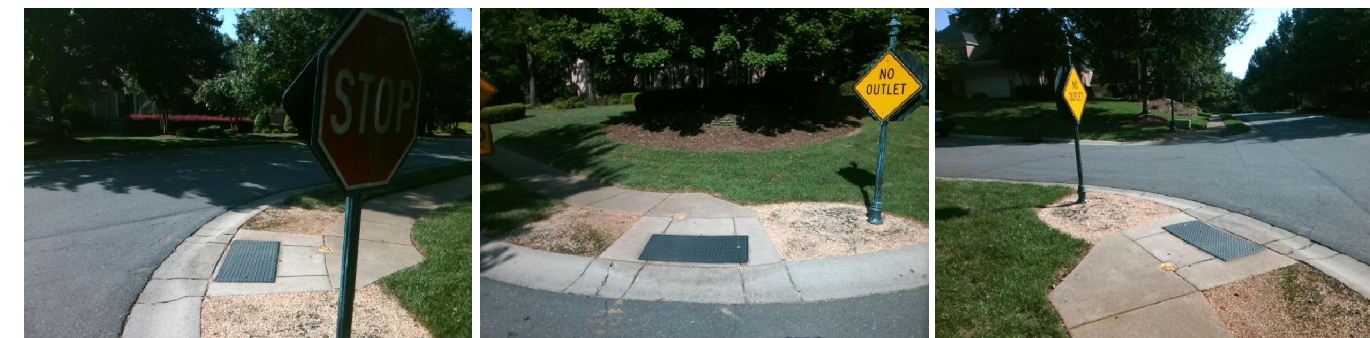
Compliance	Description	Data	Compliance	Description	Data
N/A	Ramp Length (in)	50.0	Yes	Ramp Slope (%)	7.5
No	Ramp Width (in)	35.0	Yes	Ramp XSlope (%)	1.1
N/A	Flare Type LT	N/A	N/A	Flare Type RT	N/A
N/A	Flare Slope LT (%)	N/A	N/A	Flare Slope RT (%)	N/A
N/A	Flare Traversable LT?	N/A	N/A	Flare Traversable RT?	N/A
N/A	Landing Length (in)	N/A	N/A	DWS Provided?	N/A
N/A	Landing Width (in)	N/A	N/A	DWS Contrast?	N/A
N/A	Landing Slope (%)	N/A	N/A	DWS Length (in)	N/A
N/A	Landing X Slope (%)	N/A	N/A	DWS Full Width?	N/A
N/A	Landing Curb? (Y/N)	N/A	N/A	DWS Offset (in)	N/A
N/A	Shared Landing?	N/A			
N/A	Gutter Ponding?	N/A	N/A	Gutter Slope (%)	N/A
N/A	Gutter Lip Ht (in)	N/A	N/A	Gutter X Slope (%)	N/A
N/A	Painted X Walk1?	No	N/A	Painted X Walk2?	No
	X Walk 1 Direction	To SE		X Walk 2 Direction	To NE
N/A	X Walk 1 Width (in)	N/A	N/A	X Walk 2 Width (in)	N/A
	X Walk 1 Slope (%)	1.5		X Walk 2 Slope (%)	2.0
	X Walk 1 X Slope (%)	3.8		X Walk 2 X Slope (%)	2.9

Remove & Replace Curb Ramp With Two New Directional Ramps or Equivalent.
