Access Compliance Report

Public Rights-of-Way

(Curb Ramps)

Intersection ID: 10570	Main Street: HERRIN_AV	Cross Street: HOLT_ST	Location: SW
ADA ID: 3ED00AC432E9	Ramp Type: Combination2	Initial Pass/Fail: Fail	Overall Compliance: No
		Severity Score: 22.5

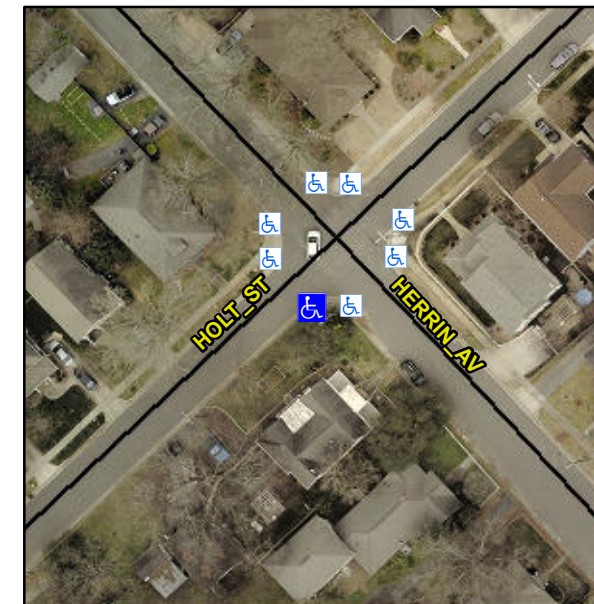
Not Found, R304.5.1, R304.3.2, R304.5.3

Compliance	Description	Data	Compliance	Description	Data
N/A	Ramp Length LT (in)	49.0	N/A	Ramp Length RT (in)	N/A
No	Ramp Width LT (in)	46.0	N/A	Ramp Width RT (in)	N/A
No	Ramp Slope LT (%)	8.9	N/A	Ramp Slope RT (%)	N/A
No	Ramp XSlope LT (%)	2.6	N/A	Ramp XSlope RT (%)	N/A
N/A	Ramp Length (in)	26.5	Yes	Ramp Slope (%)	6.3
Yes	Ramp Width (in)	48.0	Yes	Ramp XSlope (%)	0.7
N/A	Flare Type LT	N/A	N/A	Flare Type RT	N/A
N/A	Flare Slope LT (%)	N/A	N/A	Flare Slope RT (%)	N/A
N/A	Flare Traversable LT?	N/A	N/A	Flare Traversable RT?	N/A
N/A	Landing Length (in)	N/A	N/A	DWS Provided?	N/A
N/A	Landing Width (in)	N/A	N/A	DWS Contrast?	N/A
N/A	Landing Slope (%)	N/A	N/A	DWS Length (in)	N/A
N/A	Landing X Slope (%)	N/A	N/A	DWS Full Width?	N/A
N/A	Landing Curb? (Y/N)	N/A	N/A	DWS Offset (in)	N/A
N/A	Shared Landing?	N/A			
N/A	Gutter Ponding?	N/A	N/A	Gutter Slope (%)	N/A
N/A	Gutter Lip Ht (in)	N/A	N/A	Gutter X Slope (%)	N/A
N/A	Painted X Walk1?	No	N/A	Painted X Walk2?	N/A

X Walk 1 Direction	To NW		X Walk 2 Direction	N/A
	X Walk 1 Width (in)	N/A		X Walk 2 Width (in)	N/A
	X Walk 1 Slope (%)	0.2		X Walk 2 Slope (%)	N/A
	X Walk 1 X Slope (%)	2.0		X Walk 2 X Slope (%)	N/A
N/A	Ramp inside XWalk1?	N/A	N/A	Ramp inside XWalk2?	N/A
	Road Slope (%)	N/A		Clear Space?	N/A
	Road X Slope (%)	N/A	N/A	Clear Space to XWalk (in)	N/A
			N/A	Any Obstruction?	N/A
				Obstruction Type	N/A
			N/A	Storm Grate/Utility Hazard?	N/A
				Storm Grate/Utility Type	N/A
					N/A
Yes	Surface Condition? (G/P)	Good			
	Curb Slope (%)	16.2

Remove & Replace Entire Ramp.
