Access Compliance Report

Public Rights-of-Way

(Curb Ramps)

Intersection ID: 52127	Main Street: VALLEYDALE_RD	Cross Street: FRED_D_ALEXANDER_BV	Location: S
ADA ID: 412AF1DB66B1	Ramp Type: Combination1	Initial Pass/Fail: Fail	Overall Compliance: No
			Severity Score: 13.75

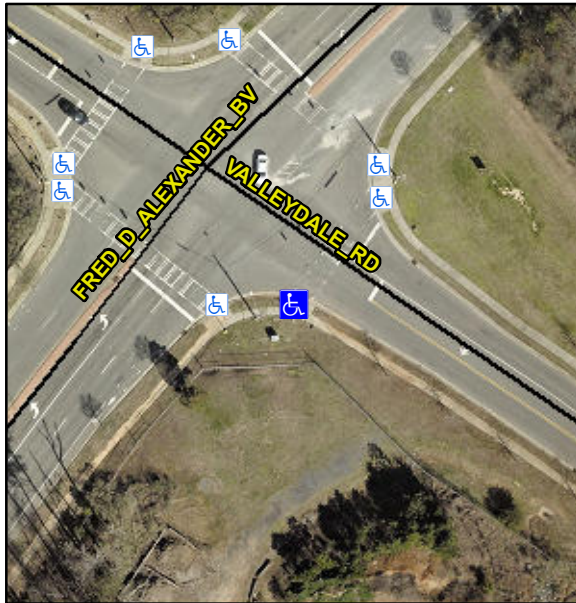
RP < 5%

Not Found, R304.5.3, R304.3.2

Compliance	Description	Data	Compliance	Description	Data
N/A	Ramp Length LT (in)	61.0	N/A	Ramp Length RT (in)	62.0
Yes	Ramp Width LT (in)	58.0	Yes	Ramp Width RT (in)	58.0
Yes	Ramp Slope LT (%)	7.0	No	Ramp Slope RT (%)	8.7
No	Ramp XSlope LT (%)	2.8	Yes	Ramp XSlope RT (%)	0.3
N/A	Ramp Length (in)	54.0	Yes	Ramp Slope (%)	3.3
Yes	Ramp Width (in)	55.0	Yes	Ramp XSlope (%)	0.7
N/A	Flare Type LT	N/A	N/A	Flare Type RT	N/A
N/A	Flare Slope LT (%)	N/A	N/A	Flare Slope RT (%)	N/A
N/A	Flare Traversable LT?	N/A	N/A	Flare Traversable RT?	N/A
N/A	Landing Length (in)	N/A	N/A	DWS Provided?	N/A
N/A	Landing Width (in)	N/A	N/A	DWS Contrast?	N/A
N/A	Landing Slope (%)	N/A	N/A	DWS Length (in)	N/A
N/A	Landing X Slope (%)	N/A	N/A	DWS Full Width?	N/A
N/A	Landing Curb? (Y/N)	N/A	N/A	DWS Offset (in)	N/A
N/A	Shared Landing?	N/A			
N/A	Gutter Ponding?	N/A	N/A	Gutter Slope (%)	N/A
N/A	Gutter Lip Ht (in)	N/A	N/A	Gutter X Slope (%)	N/A
N/A	Painted X Walk1?	Yes	N/A	Painted X Walk2?	N/A

X Walk 1 Direction	To NE		X Walk 2 Direction	N/A
	X Walk 1 Width (in)	110.0		X Walk 2 Width (in)	N/A
	X Walk 1 Slope (%)	0.9		X Walk 2 Slope (%)	N/A
	X Walk 1 X Slope (%)	1.6		X Walk 2 X Slope (%)	N/A
N/A	Ramp inside XWalk1?	Yes	N/A	Ramp inside XWalk2?	N/A
	Road Slope (%)	N/A		Clear Space?	N/A
	Road X Slope (%)	N/A	N/A	Clear Space to XWalk (in)	N/A
			N/A	Any Obstruction?	N/A
				Obstruction Type	N/A
			N/A	Storm Grate/Utility Hazard?	N/A
				Storm Grate/Utility Type	N/A
			Yes	Surface Condition? (G/P)	Good
				Curb Slope (%)	10.8

Remove & Replace Entire Ramp.
