# Access Compliance Report

## Public Rights-of-Way

### (Curb Ramps)

Intersection ID: 24674	Main Street: CARMEL_RD	Cross Street: CARMEL_VISTA_LN	Location: SE
ADA ID: 41E130B3EDA4	Ramp Type: Perp	Initial Pass/Fail: Fail	Overall Compliance: No
		Severity Score: 10

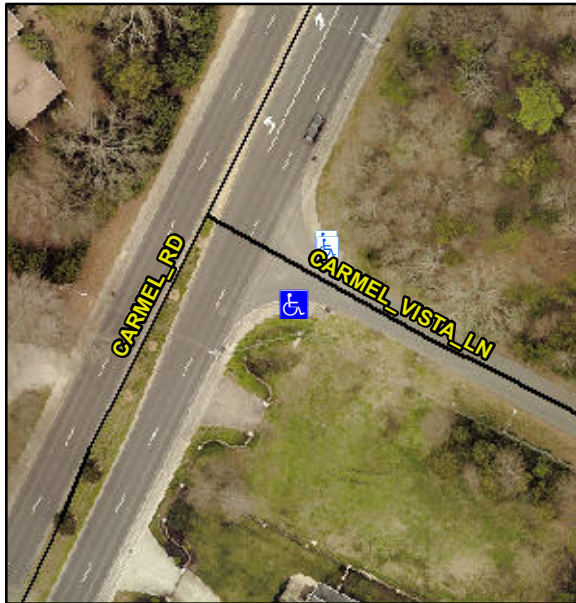
**Not Found, R304.5.1, R304.5.3**

Compliance	Description	Data	Compliance	Description	Data
N/A	Ramp Length (in)	57.0	Yes	Ramp Slope (%)	7.4
No	Ramp Width (in)	37.0	No	Ramp XSlope (%)	2.1
N/A	Flare Type LT	N/A	N/A	Flare Type RT	N/A
N/A	Flare Slope LT (%)	N/A	N/A	Flare Slope RT (%)	N/A
N/A	Flare Traversable LT?	N/A	N/A	Flare Traversable RT?	N/A
N/A	Landing Length (in)	N/A	N/A	DWS Provided?	N/A
N/A	Landing Width (in)	N/A	N/A	DWS Contrast?	N/A
N/A	Landing Slope (%)	N/A	N/A	DWS Length (in)	N/A
N/A	Landing X Slope (%)	N/A	N/A	DWS Full Width?	N/A
N/A	Landing Curb? (Y/N)	N/A	N/A	DWS Offset (in)	N/A
N/A	Shared Landing?	N/A			
N/A	Gutter Ponding?	N/A	N/A	Gutter Slope (%)	N/A
N/A	Gutter Lip Ht (in)	N/A	N/A	Gutter X Slope (%)	N/A
N/A	Painted X Walk1?	No	N/A	Painted X Walk2?	N/A
	X Walk 1 Direction	To NE		X Walk 2 Direction	N/A
N/A	X Walk 1 Width (in)	N/A	N/A	X Walk 2 Width (in)	N/A
	X Walk 1 Slope (%)	1.6		X Walk 2 Slope (%)	N/A
	X Walk 1 X Slope (%)	1.4		X Walk 2 X Slope (%)	N/A

N/A	Ramp inside XWalk1?	N/A	N/A	Ramp inside XWalk2?	N/A
	Road Slope (%)	N/A	N/A	Clear Space?	N/A
	Road X Slope (%)	N/A	N/A	Clear Space to XWalk (in)	N/A
N/A	Any Obstructions?	N/A	N/A	Storm Grate/Utility Hazard?	N/A
	Obstruction Type			Storm Grate/Utility Type	
		N/A			N/A
			Yes	Surface Condition? (G/P)	Good

**Remove & Replace Entire Ramp.**
