Access Compliance Report

Public Rights-of-Way

(Curb Ramps)

Intersection ID: 24183	Main Street: COMPTON_CT	Cross Street: LUTZEN_WAY_CT	Location: SW
ADA ID: 428105C53FFB	Ramp Type: PerpDiag	Initial Pass/Fail: Fail	Overall Compliance: No
		Severity Score: 8.75

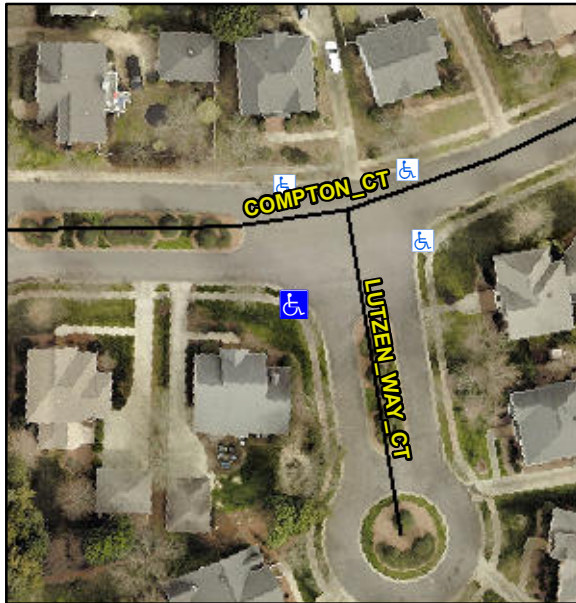
Not Found, R304.5.1

Compliance	Description	Data	Compliance	Description	Data
N/A	Ramp Length (in)	48.0	Yes	Ramp Slope (%)	7.3
No	Ramp Width (in)	46.0	Yes	Ramp XSlope (%)	0.6
N/A	Flare Type LT	N/A	N/A	Flare Type RT	N/A
N/A	Flare Slope LT (%)	N/A	N/A	Flare Slope RT (%)	N/A
N/A	Flare Traversable LT?	N/A	N/A	Flare Traversable RT?	N/A
N/A	Landing Length (in)	N/A	N/A	DWS Provided?	N/A
N/A	Landing Width (in)	N/A	N/A	DWS Contrast?	N/A
N/A	Landing Slope (%)	N/A	N/A	DWS Length (in)	N/A
N/A	Landing X Slope (%)	N/A	N/A	DWS Full Width?	N/A
N/A	Landing Curb? (Y/N)	N/A	N/A	DWS Offset (in)	N/A
N/A	Shared Landing?	N/A			
N/A	Gutter Ponding?	N/A	N/A	Gutter Slope (%)	N/A
N/A	Gutter Lip Ht (in)	N/A	N/A	Gutter X Slope (%)	N/A
N/A	Painted X Walk1?	No	N/A	Painted X Walk2?	No
	X Walk 1 Direction	To E		X Walk 2 Direction	To N
N/A	X Walk 1 Width (in)	N/A	N/A	X Walk 2 Width (in)	N/A
	X Walk 1 Slope (%)	6.0		X Walk 2 Slope (%)	4.2
	X Walk 1 X Slope (%)	2.6		X Walk 2 X Slope (%)	4.6

N/A	Ramp inside XWalk1?	N/A	N/A	Ramp inside XWalk2?	N/A
	Road Slope (%)	1.6	N/A	Clear Space?	N/A
	Road X Slope (%)	7.2	N/A	Clear Space to XWalk (in)	N/A
N/A	Any Obstructions?	N/A	N/A	Storm Grate/Utility Hazard?	N/A
	Obstruction Type			Storm Grate/Utility Type	
		N/A			N/A
			Yes	Surface Condition? (G/P)	Good

Remove & Replace Curb Ramp With Two New Directional Ramps or Equivalent.
