Access Compliance Report

Public Rights-of-Way

(Curb Ramps)

Intersection ID: 17190	Main Street: MURRAYHILL_RD	Cross Street: SCALEYBARK_RD	Location: S
ADA ID: 4350C0C4D668	Ramp Type: Combination2Diag	Initial Pass/Fail: Fail	Overall Compliance: No
Severity Score: 0			
Codes/Mitigation Info/Possible Solution		Field Measurements/Component Compliance

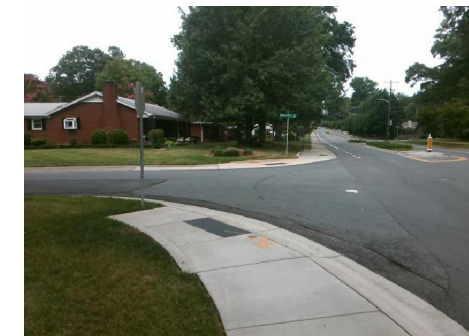
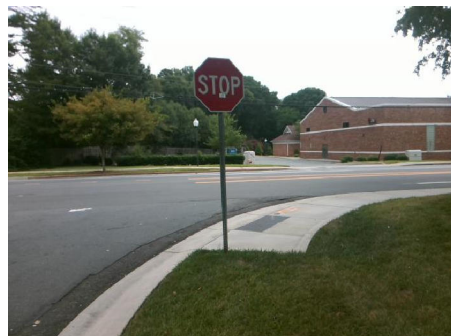
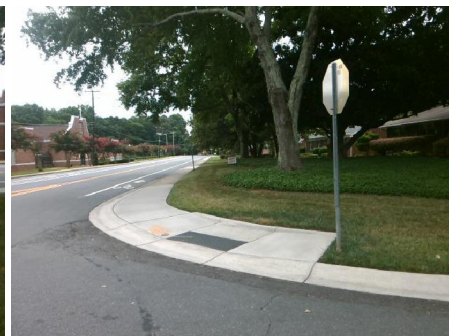
Not Found, R304.5.1, R304.5.3

Compliance	Description	Data	Compliance	Description	Data
N/A	Ramp Length LT (in)	48.0	N/A	Ramp Length RT (in)	N/A
No	Ramp Width LT (in)	34.0	N/A	Ramp Width RT (in)	N/A
Yes	Ramp Slope LT (%)	5.2	N/A	Ramp Slope RT (%)	N/A
No	Ramp XSlope LT (%)	3.2	N/A	Ramp XSlope RT (%)	N/A
N/A	Ramp Length (in)	24.0	Yes	Ramp Slope (%)	4.3
Yes	Ramp Width (in)	60.0	Yes	Ramp XSlope (%)	0.1
N/A	Flare Type LT	N/A	N/A	Flare Type RT	N/A
N/A	Flare Slope LT (%)	N/A	N/A	Flare Slope RT (%)	N/A
N/A	Flare Traversable LT?	N/A	N/A	Flare Traversable RT?	N/A
N/A	Landing Length (in)	N/A	N/A	DWS Provided?	N/A
N/A	Landing Width (in)	N/A	N/A	DWS Contrast?	N/A
N/A	Landing Slope (%)	N/A	N/A	DWS Length (in)	N/A
N/A	Landing X Slope (%)	N/A	N/A	DWS Full Width?	N/A
N/A	Landing Curb? (Y/N)	N/A	N/A	DWS Offset (in)	N/A
N/A	Shared Landing?	N/A			
N/A	Gutter Ponding?	N/A	N/A	Gutter Slope (%)	N/A
N/A	Gutter Lip Ht (in)	N/A	N/A	Gutter X Slope (%)	N/A
N/A	Painted X Walk1?	No	N/A	Painted X Walk2?	No

X Walk 1 Direction	To NE		X Walk 2 Direction	To NW
	X Walk 1 Width (in)	N/A		X Walk 2 Width (in)	N/A
	X Walk 1 Slope (%)	1.7		X Walk 2 Slope (%)	0.6
	X Walk 1 X Slope (%)	0.6		X Walk 2 X Slope (%)	0.8
N/A	Ramp inside XWalk1?	N/A	N/A	Ramp inside XWalk2?	N/A
	Road Slope (%)	0.1		Clear Space?	N/A
	Road X Slope (%)	2.2	N/A	Clear Space to XWalk (in)	N/A
			N/A	Any Obstruction?	N/A
				Obstruction Type	N/A
			N/A	Storm Grate/Utility Hazard?	N/A
				Storm Grate/Utility Type	N/A
Yes	Surface Condition? (G/P)	Good			
	Curb Slope (%)	14.9

Remove & Replace Curb Ramp With Two New Directional Ramps or Equivalent.
