# Access Compliance Report

## Public Rights-of-Way

| Intersection ID: 19146 | Main Street: TYVOLA_RD | Cross Street: WEDGEWOOD_DR | Location: NE |
| ADA ID: 43DDFB5763A0 | Ramp Type: BlendTrans2 | Initial Pass/Fail: Pass | Overall Compliance: No |

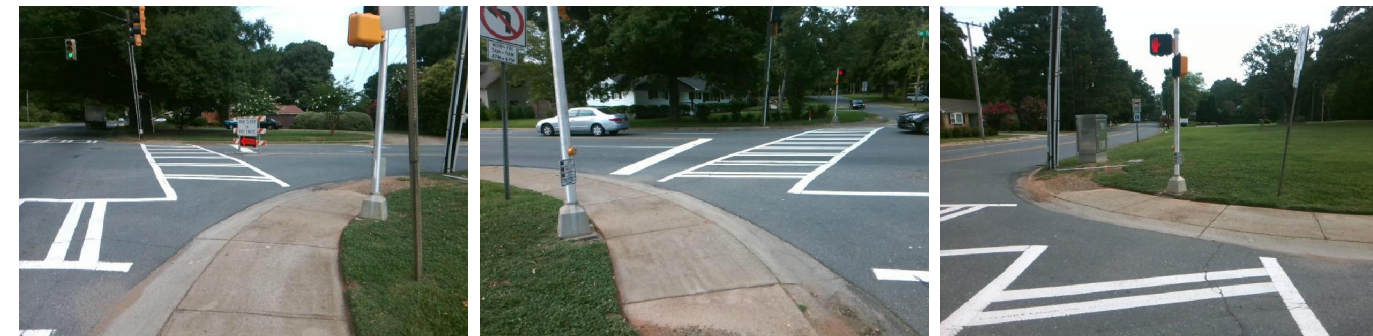
**Not Found, R305, R302.7, R302.7.2, R304.5.4**

| Compliance | Description | Data | Compliance | Description | Data |
|---|---|---|---|---|---|
| N/A | Landing Length (in) | N/A | No | DWS Provided? | No |
| | | | No | Curb Slope (%) | 20.2 |

**Remove & Replace Curb Ramp With Two New Directional Ramps or Equivalent. Remove & Replace Gutter.**
