Access Compliance Report

Public Rights-of-Way

Intersection ID: 14278	Main Street: ROMARE_BEARDEN_DR	Cross Street: FARMER_ST	Location: W
ADA ID: 44E53FBE7456	Ramp Type: MedianPerp	Initial Pass/Fail: Fail	Overall Compliance: No
Severity Score: 1.25			
Codes/Mitigation Info/Possible Solution		Field Measurements/Component Compliance

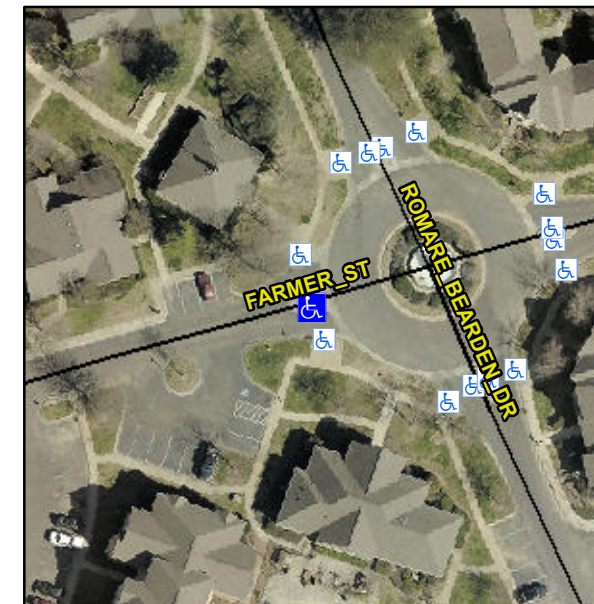
Not Found, R304.5.3

Compliance	Description	Data	Compliance	Description	Data
N/A	Ramp Length (in)	43.0	Yes	Ramp Slope (%)	6.4
Yes	Ramp Width (in)	58.0	No	Ramp XSlope (%)	3.0
N/A	Flare Type LT	N/A	N/A	Flare Type RT	N/A
N/A	Flare Slope LT (%)	N/A	N/A	Flare Slope RT (%)	N/A
N/A	Flare Traversable LT?	N/A	N/A	Flare Traversable RT?	N/A
N/A	Landing Length (in)	N/A	N/A	DWS Provided?	N/A
N/A	Landing Width (in)	N/A	N/A	DWS Contrast?	N/A
N/A	Landing Slope (%)	N/A	N/A	DWS Length (in)	N/A
N/A	Landing X Slope (%)	N/A	N/A	DWS Full Width?	N/A
N/A	Landing Curb? (Y/N)	N/A	N/A	DWS Offset (in)	N/A
N/A	Shared Landing?	N/A			
N/A	Gutter Ponding?	N/A	N/A	Gutter Slope (%)	N/A
N/A	Gutter Lip Ht (in)	N/A	N/A	Gutter X Slope (%)	N/A
N/A	Painted X Walk1?	No	N/A	Painted X Walk2?	N/A
	X Walk 1 Direction	To S		X Walk 2 Direction	N/A
N/A	X Walk 1 Width (in)	N/A	N/A	X Walk 2 Width (in)	N/A
	X Walk 1 Slope (%)	0.6		X Walk 2 Slope (%)	N/A
	X Walk 1 X Slope (%)	0.5		X Walk 2 X Slope (%)	N/A

Remove & Replace Entire Ramp.
