# Access Compliance Report

## Public Rights-of-Way

### (Curb Ramps)

| Intersection ID: 49791 | Main Street: BAHIA_LN | Cross Street: BARLEY_LN | Location: | N |

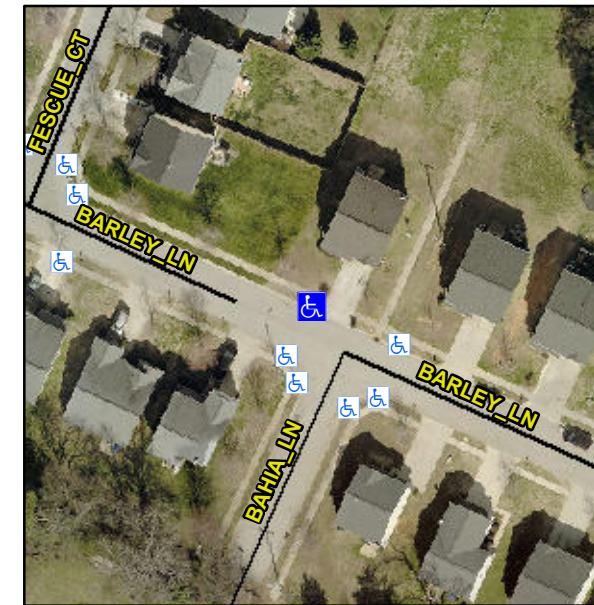
**Not Found, R304.5.3, R304.2.1,  
R304.2.2-Perp, R304.3.2-Para**

| Compliance | Description | Data | Compliance | Description | Data |
|---|---|---|---|---|---|
| Yes | Ramp Width (in) | 48.0 | No | Ramp XSlope (%) | 2.6 |
| No | Landing Length (in) | 25.0 | Yes | DWS Provided? | Yes |
| No | Landing Width (in) | 47.5 | Yes | DWS Contrast? | Yes |
| No | Landing Slope (%) | 4.7 | Yes | DWS Length (in) | 24.0 |
| No | Landing X Slope (%) | 3.1 | Yes | DWS Full Width? | Yes |
| Yes | Gutter Lip Ht (in) | 0.0 | No | Gutter X Slope (%) | 2.9 |

**Remove & Replace Entire Ramp.  
Remove & Replace Gutter.**
