Access Compliance Report

Public Rights-of-Way

(Curb Ramps)

Intersection ID: 11552	Main Street: ANNE_ST	Cross Street: CHERYL_ST	Location: NW
ADA ID: 45CEB2E31C5F	Ramp Type: Combination2Diag	Initial Pass/Fail: Fail	Overall Compliance: No
		Severity Score: 0

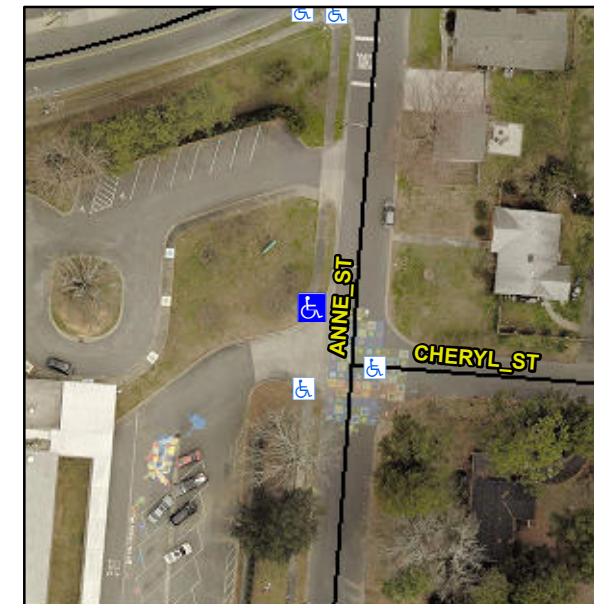
R304.5.1, R304.5.3, R304.3.2

Compliance	Description	Data	Compliance	Description	Data
N/A	Ramp Length LT (in)	N/A	N/A	Ramp Length RT (in)	51.0
N/A	Ramp Width LT (in)	N/A	Yes	Ramp Width RT (in)	59.0
N/A	Ramp Slope LT (%)	N/A	No	Ramp Slope RT (%)	9.6
N/A	Ramp XSlope LT (%)	N/A	No	Ramp XSlope RT (%)	2.9
N/A	Ramp Length (in)	54.0	Yes	Ramp Slope (%)	5.5
No	Ramp Width (in)	46.0	No	Ramp XSlope (%)	3.5
N/A	Flare Type LT	N/A	N/A	Flare Type RT	N/A
N/A	Flare Slope LT (%)	N/A	N/A	Flare Slope RT (%)	N/A
N/A	Flare Traversable LT?	N/A	N/A	Flare Traversable RT?	N/A
N/A	Landing Length (in)	N/A	N/A	DWS Provided?	N/A
N/A	Landing Width (in)	N/A	N/A	DWS Contrast?	N/A
N/A	Landing Slope (%)	N/A	N/A	DWS Length (in)	N/A
N/A	Landing X Slope (%)	N/A	N/A	DWS Full Width?	N/A
N/A	Landing Curb? (Y/N)	N/A	N/A	DWS Offset (in)	N/A
N/A	Shared Landing?	N/A			
N/A	Gutter Ponding?	N/A	N/A	Gutter Slope (%)	N/A
N/A	Gutter Lip Ht (in)	N/A	N/A	Gutter X Slope (%)	N/A
N/A	Painted X Walk1?	No	N/A	Painted X Walk2?	No

Remove & Replace Curb Ramp With Two New Directional Ramps or Equivalent.
