Access Compliance Report

Public Rights-of-Way

(Curb Ramps)

Intersection ID: 12833	Main Street: HICKORY GROVE RD	Cross Street: VALLEYVIEW DR	Location: SE
ADA ID: 4614F8461CDB	Ramp Type: Combination1	Initial Pass/Fail: Fail	Overall Compliance: No
		Severity Score: 10

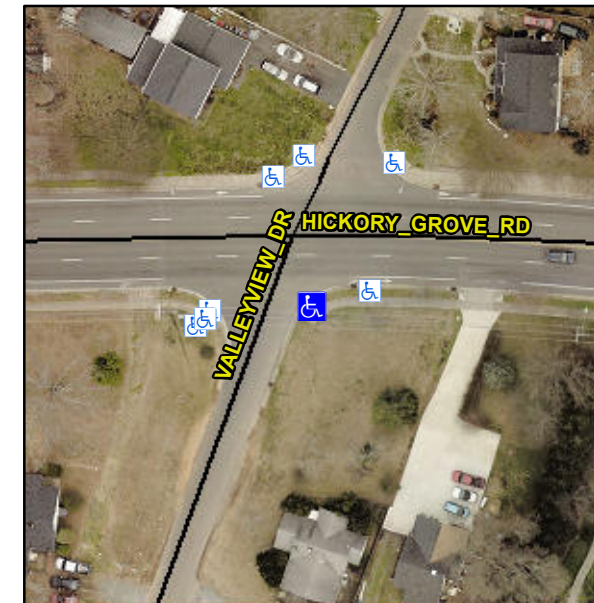
LT RP < 5%

Not Found, R304.5.1, R304.5.3

Compliance	Description	Data	Compliance	Description	Data
N/A	Ramp Length LT (in)	46.0	N/A	Ramp Length RT (in)	50.5
Yes	Ramp Width LT (in)	60.5	Yes	Ramp Width RT (in)	60.5
Yes	Ramp Slope LT (%)	0.9	Yes	Ramp Slope RT (%)	7.6
No	Ramp XSlope LT (%)	2.3	Yes	Ramp XSlope RT (%)	1.5
N/A	Ramp Length (in)	49.0	Yes	Ramp Slope (%)	6.1
No	Ramp Width (in)	41.5	No	Ramp XSlope (%)	3.1
N/A	Flare Type LT	N/A	N/A	Flare Type RT	N/A
N/A	Flare Slope LT (%)	N/A	N/A	Flare Slope RT (%)	N/A
N/A	Flare Traversable LT?	N/A	N/A	Flare Traversable RT?	N/A
N/A	Landing Length (in)	N/A	N/A	DWS Provided?	N/A
N/A	Landing Width (in)	N/A	N/A	DWS Contrast?	N/A
N/A	Landing Slope (%)	N/A	N/A	DWS Length (in)	N/A
N/A	Landing X Slope (%)	N/A	N/A	DWS Full Width?	N/A
N/A	Landing Curb? (Y/N)	N/A	N/A	DWS Offset (in)	N/A
N/A	Shared Landing?	N/A			
N/A	Gutter Ponding?	N/A	N/A	Gutter Slope (%)	N/A
N/A	Gutter Lip Ht (in)	N/A	N/A	Gutter X Slope (%)	N/A
N/A	Painted X Walk1?	No	N/A	Painted X Walk2?	N/A

Remove & Replace Entire Ramp.
