# Access Compliance Report

## Public Rights-of-Way

### (Curb Ramps)

Intersection ID: 31368	Main Street: GREENWAY_VISTA_LN	Cross Street: LINDA_VISTA_LN	Location: W
ADA ID: 46540F780ACE	Ramp Type: BlendTrans1	Initial Pass/Fail: Fail	Overall Compliance: No
		Severity Score: 15

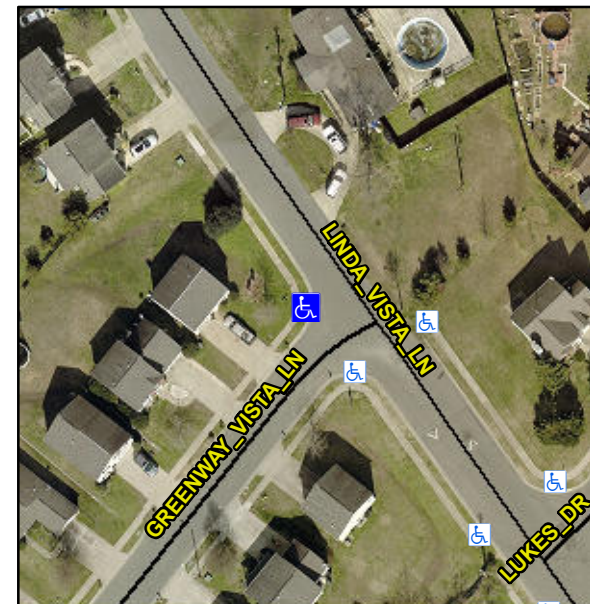
**Not Found, R302.7**

Compliance	Description	Data	Compliance	Description	Data
N/A	Ramp Length (in)	46.0	Yes	BlendTrans Slope (%)	3.5
Yes	Ramp Width (in)	51.0	Yes	BlendTrans XSlope (%)	1.5
N/A	Flare Type LT	N/A	N/A	Flare Type RT	N/A
N/A	Flare Slope LT (%)	N/A	N/A	Flare Slope RT (%)	N/A
N/A	Flare Traversable LT?	N/A	N/A	Flare Traversable RT?	N/A
N/A	Landing Length (in)	N/A	N/A	DWS Provided?	N/A
N/A	Landing Width (in)	N/A	N/A	DWS Contrast?	N/A
N/A	Landing Slope (%)	N/A	N/A	DWS Length (in)	N/A
N/A	Landing X Slope (%)	N/A	N/A	DWS Full Width?	N/A
N/A	Landing Curb? (Y/N)	N/A	N/A	DWS Offset (in)	N/A
N/A	Shared Landing?	N/A			
N/A	Gutter Ponding?	N/A	N/A	Gutter Slope (%)	N/A
N/A	Gutter Lip Ht (in)	N/A	N/A	Gutter X Slope (%)	N/A
N/A	Painted X Walk1?	No	N/A	Painted X Walk2?	N/A
	X Walk 1 Direction	To SE		X Walk 2 Direction	N/A
	X Walk 1 Width (in)	N/A		X Walk 2 Width (in)	N/A
	X Walk 1 Slope (%)	2.0		X Walk 2 Slope (%)	N/A
	X Walk 1 X Slope (%)	1.8		X Walk 2 X Slope (%)	N/A

N/A	Ramp inside XWalk1?	N/A	N/A	Ramp inside XWalk2?	N/A
	Road Slope (%)	1.8		Clear Space?	N/A
	Road X Slope (%)	2.0	N/A	Clear Space to XWalk (in)	N/A
N/A	Any Obstructions?	N/A	N/A	Storm Grate/Utility Hazard?	N/A
	Obstruction Type			Storm Grate/Utility Type	
		N/A			N/A
			No	Surface Condition? (G/P)	Poor
			No	Curb Slope (%)	7.3

**Remove & Replace Curb Ramp With Two New Directional Ramps or Equivalent.**
