Access Compliance Report

Public Rights-of-Way

| Intersection ID: 3595 | Main Street: CLAIBORNE_WOODS_RD | Cross Street: TARPAN_CT | Location: | N |
| ADA ID: 468452C23C58 | Ramp Type: BlendTrans2 | Initial Pass/Fail: Fail | Overall Compliance: No | Severity Score: 1.25 |

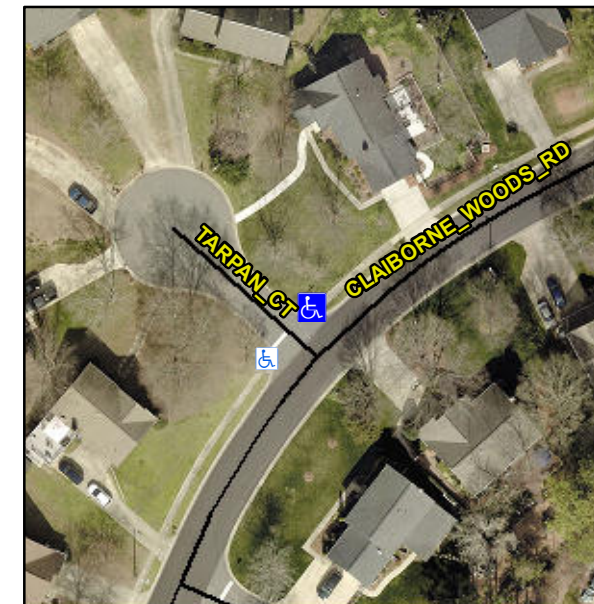
Not Found, R304.5.3

| Compliance | Description | Data | Compliance | Description | Data |
|---|---|---|---|---|---|
| Yes | Ramp Width (in) | 48.0 | No | BlendTrans XSlope (%) | 3.5 |

Remove & Replace Curb Ramp With Two New Directional Ramps or Equivalent.
