Access Compliance Report

Public Rights-of-Way

(Curb Ramps)

Intersection ID: 18787	Main Street: MONROE_RD	Cross Street: WOODBERRY_RD	Location: NE
ADA ID: 4742348D4A56	Ramp Type: PerpDiag	Initial Pass/Fail: Fail	Overall Compliance: No
		Severity Score: 13.75

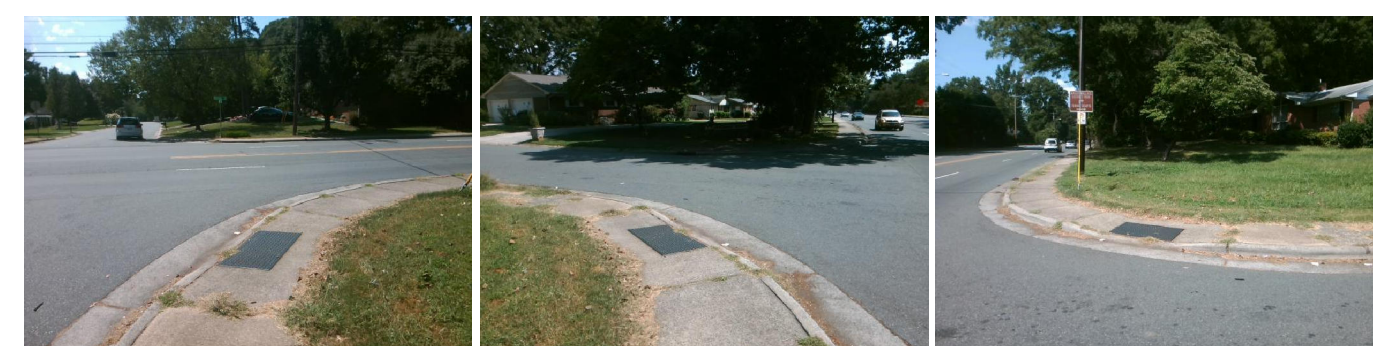
N/A	X Walk 2 Width (in)	N/A
			4.0	X Walk 2 Slope (%)	0.8
			2.0	X Walk 2 X Slope (%)	0.9
			N/A	Ramp inside XWalk2?	N/A
			2.0	Clear Space?	N/A
			1.1	Clear Space to XWalk (in)	N/A
			N/A	Storm Grate/Utility Hazard?	N/A
			N/A	Storm Grate/Utility Type	N/A
			N/A	Surface Condition? (G/P)	Good

Possible Solutions:		Compliance	Description	Data
	Remove & Replace Curb Ramp With Two New Directional Ramps or Equivalent.		No	Ramp Length (in)	60.0
			Yes	Ramp Width (in)	48.0
			N/A	Flare Type LT	N/A
			N/A	Flare Slope LT (%)	N/A
			N/A	Flare Traversable LT?	N/A
			N/A	Landing Length (in)	N/A
			N/A	Landing Width (in)	N/A
			N/A	Landing Slope (%)	N/A
			N/A	Landing X Slope (%)	N/A
<p>Surveyor Notes:</p> <p>N/A</p> <p>PROW/ADA:</p> <p>Not Found, R304.2.2, R304.5.3</p>			N/A	Flare Type RT	N/A
			N/A	Flare Slope RT (%)	N/A
			N/A	Flare Traversable RT?	N/A
			N/A	DWS Provided?	N/A
			N/A	DWS Contrast?	N/A
			N/A	DWS Length (in)	N/A
			N/A	DWS Full Width?	N/A
			N/A	DWS Offset (in)	N/A
			N/A	Gutter Ponding?	N/A
			N/A	Gutter Lip Ht (in)	N/A
<p>Total Cost:</p> <p>\$ 3200.00</p>			No	Painted X Walk2?	No
			To W	X Walk 2 Direction	To S
