Access Compliance Report

Public Rights-of-Way

(Curb Ramps)

Intersection ID: 15072	Main Street: DILWORTH_RD_EAST	Cross Street: E WORTHINGTON AV	Location: N
ADA ID: 47BBDB338C1B	Ramp Type: Perp	Initial Pass/Fail: Fail	Overall Compliance: No
			Severity Score: 26.25

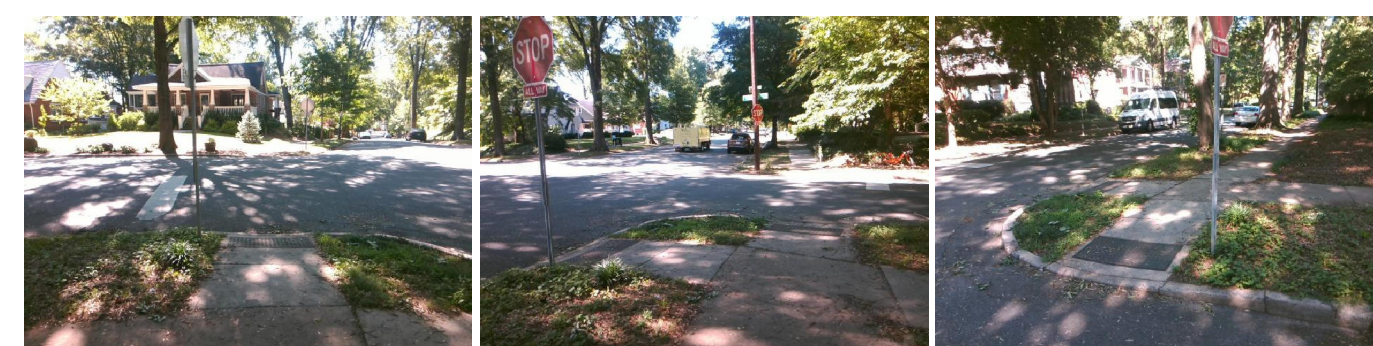
Possible Solutions:		Compliance	Description	Data
	Remove & Replace Entire Ramp.		N/A	Ramp Length (in)	99.0
			Yes	Ramp Width (in)	48.0
			N/A	Flare Type LT	N/A
			N/A	Flare Slope LT (%)	N/A
			N/A	Flare Traversable LT?	N/A
			N/A	Landing Length (in)	N/A
			N/A	Landing Width (in)	N/A
			N/A	Landing Slope (%)	N/A
			N/A	Landing X Slope (%)	N/A
<p>Surveyor Notes:</p> <p>N/A</p> <p>PROW/ADA:</p> <p>Not Found, R304.2.2, R304.5.3</p>			N/A	Flare Type RT	N/A
			N/A	Flare Slope RT (%)	N/A
			N/A	Flare Traversable RT?	N/A
			N/A	DWS Provided?	N/A
			N/A	DWS Contrast?	N/A
			N/A	DWS Length (in)	N/A
			N/A	DWS Full Width?	N/A
			N/A	DWS Offset (in)	N/A
			N/A	Shared Landing?	N/A
			N/A	Gutter Ponding?	N/A
			N/A	Gutter Lip Ht (in)	2.0
			N/A	Painted X Walk1?	No
				X Walk 1 Direction	To SE
			N/A	X Walk 1 Width (in)	N/A
				X Walk 1 Slope (%)	5.4

X Walk 1 X Slope (%)	1.8
			N/A	Ramp inside XWalk1?	N/A
				Road Slope (%)	N/A
				Road X Slope (%)	N/A
			N/A	Any Obstructions?	N/A
				Obstruction Type	
Total Cost:		\$ 1850.00			
			N/A		N/A
			Yes	Surface Condition? (G/P)	Good
