Access Compliance Report

Public Rights-of-Way

(Curb Ramps)

Intersection ID: 14471	Main Street: DILWORTH_RD	Cross Street: LINGANORE_PL	Location: SE
ADA ID: 4AB43EEB9F00	Ramp Type: PerpDiag	Initial Pass/Fail: Pass	Overall Compliance: No
Severity Score: 15.25			
Codes/Mitigation Info/Possible Solution		Field Measurements/Component Compliance

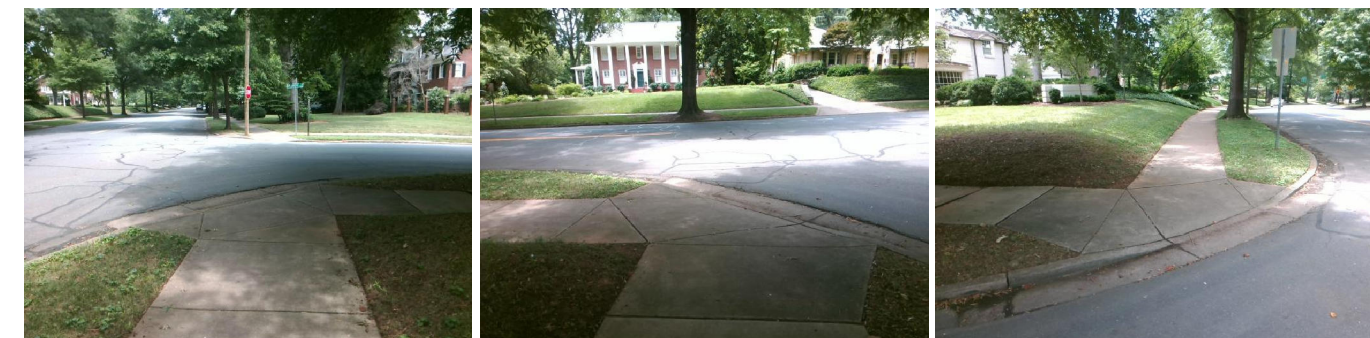
Not Found, R304.5.3, R304.2.2-Perp, R304.3.2-Para, R305, R302.7, R304.5.4

Compliance	Description	Data	Compliance	Description	Data
N/A	Ramp Length (in)	61.0	Yes	Ramp Slope (%)	7.2
Yes	Ramp Width (in)	70.0	No	Ramp XSlope (%)	3.6
N/A	Flare Type LT	Sloped	N/A	Flare Type RT	N/A
N/A	Flare Slope LT (%)	9.4	N/A	Flare Slope RT (%)	7.6
N/A	Flare Traversable LT?	Yes	N/A	Flare Traversable RT?	No
Yes	Landing Length (in)	48.0	No	DWS Provided?	No
Yes	Landing Width (in)	58.0	N/A	DWS Contrast?	No
No	Landing Slope (%)	2.4	N/A	DWS Length (in)	N/A
No	Landing X Slope (%)	2.3	N/A	DWS Full Width?	No
N/A	Landing Curb? (Y/N)	No	N/A	DWS Offset (in)	N/A
N/A	Shared Landing?	No			
No	Gutter Ponding?	Yes	No	Gutter Slope (%)	5.8
Yes	Gutter Lip Ht (in)	0.0	Yes	Gutter X Slope (%)	0.7
N/A	Painted X Walk1?	No	N/A	Painted X Walk2?	No
	X Walk 1 Direction	To N		X Walk 2 Direction	To W
N/A	X Walk 1 Width (in)	N/A	N/A	X Walk 2 Width (in)	N/A
	X Walk 1 Slope (%)	3.9		X Walk 2 Slope (%)	2.7
	X Walk 1 X Slope (%)	4.0		X Walk 2 X Slope (%)	1.7

N/A	Ramp inside XWalk1?	N/A	N/A	Ramp inside XWalk2?	N/A
	Road Slope (%)	1.5	N/A	Clear Space?	Yes
	Road X Slope (%)	4.1	N/A	Clear Space to XWalk (in)	N/A
Yes	Any Obstructions?	No	Yes	Storm Grate/Utility Hazard?	No
	Obstruction Type			Storm Grate/Utility Type	
		N/A			N/A
		Yes		Surface Condition? (G/P)	Good

Remove & Replace Curb Ramp With Two New Directional Ramps or Equivalent. Remove & Replace Gutter.
