Access Compliance Report

Public Rights-of-Way

(Curb Ramps)

Intersection ID: 13865	Main Street: CENTRAL_AV	Cross Street: TIMBER_HOLLOW_DR	Location: NW
ADA ID: 4CA8BBC485A8	Ramp Type: Combination1	Initial Pass/Fail: Fail	Overall Compliance: No
		Severity Score: 22.5

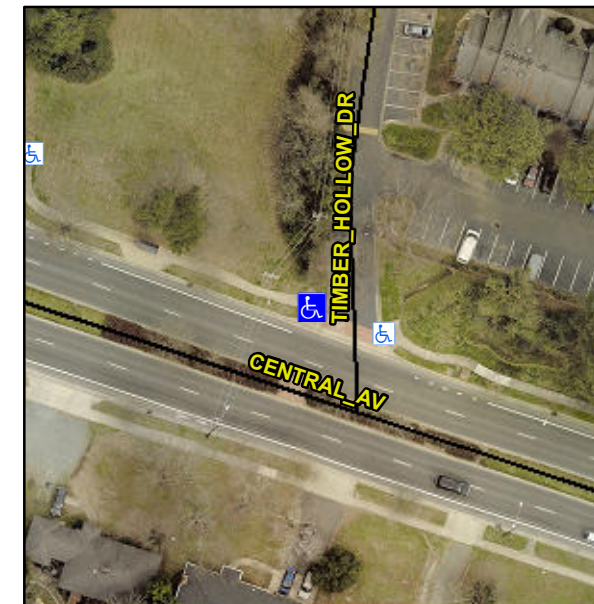
LT RP < 5%

Not Found, R304.5.1, R304.5.3, R304.3.2

Compliance	Description	Data	Compliance	Description	Data
N/A	Ramp Length LT (in)	43.0	N/A	Ramp Length RT (in)	45.0
Yes	Ramp Width LT (in)	72.0	Yes	Ramp Width RT (in)	71.0
Yes	Ramp Slope LT (%)	0.5	No	Ramp Slope RT (%)	10.7
Yes	Ramp XSlope LT (%)	1.1	Yes	Ramp XSlope RT (%)	0.4
N/A	Ramp Length (in)	72.0	Yes	Ramp Slope (%)	4.2
No	Ramp Width (in)	38.0	No	Ramp XSlope (%)	3.2
N/A	Flare Type LT	N/A	N/A	Flare Type RT	N/A
N/A	Flare Slope LT (%)	N/A	N/A	Flare Slope RT (%)	N/A
N/A	Flare Traversable LT?	N/A	N/A	Flare Traversable RT?	N/A
N/A	Landing Length (in)	N/A	N/A	DWS Provided?	N/A
N/A	Landing Width (in)	N/A	N/A	DWS Contrast?	N/A
N/A	Landing Slope (%)	N/A	N/A	DWS Length (in)	N/A
N/A	Landing X Slope (%)	N/A	N/A	DWS Full Width?	N/A
N/A	Landing Curb? (Y/N)	N/A	N/A	DWS Offset (in)	N/A
N/A	Shared Landing?	N/A			
N/A	Gutter Ponding?	N/A	N/A	Gutter Slope (%)	N/A
N/A	Gutter Lip Ht (in)	N/A	N/A	Gutter X Slope (%)	N/A
N/A	Painted X Walk1?	Yes	N/A	Painted X Walk2?	N/A

X Walk 1 Direction	To SE		X Walk 2 Direction	N/A
	X Walk 1 Width (in)	93.0		X Walk 2 Width (in)	N/A
	X Walk 1 Slope (%)	0.9		X Walk 2 Slope (%)	N/A
	X Walk 1 X Slope (%)	5.8		X Walk 2 X Slope (%)	N/A
N/A	Ramp inside XWalk1?	Yes	N/A	Ramp inside XWalk2?	N/A
	Road Slope (%)	N/A		Clear Space?	N/A
	Road X Slope (%)	N/A	N/A	Clear Space to XWalk (in)	N/A
			N/A	Any Obstruction?	N/A
				Obstruction Type	N/A
			N/A	Storm Grate/Utility Hazard?	N/A
				Storm Grate/Utility Type	N/A
			Yes	Surface Condition? (G/P)	Good
				Curb Slope (%)	20.3

Remove & Replace Entire Ramp.
