# Access Compliance Report

## Public Rights-of-Way

### (Curb Ramps)

| Intersection ID: 29330 | Main Street: IRWIN_WOOD_LN | Cross Street: NEVIN_BROOK_RD | Location: NW |

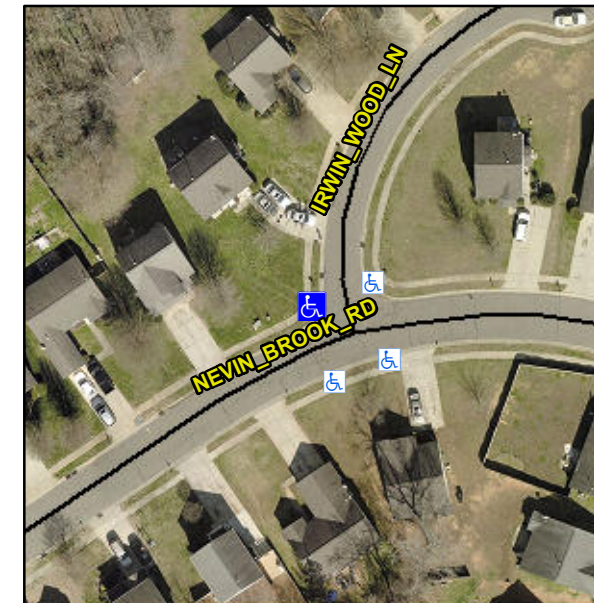
| ADA ID: 4D71BFD0CC8C | Ramp Type: BlendTrans1 | Initial Pass/Fail: Fail | Overall Compliance: No |
| | | Severity Score: 25 | |

**Not Found, R304.5.3**

| Compliance | Description | Data | Compliance | Description | Data |
|---|---|---|---|---|---|
| Yes | Ramp Width (in) | 48.0 | No | BlendTrans XSlope (%) | 7.5 |

**Remove & Replace Curb Ramp With Two New Directional Ramps or Equivalent.**

Total Cost: \$ 3200.00
