# Access Compliance Report

## Public Rights-of-Way

### (Curb Ramps)

| Intersection ID: 10018624 | Main Street: CHESTNUT_OAK_LN | Cross Street: N/A | Location: SE |

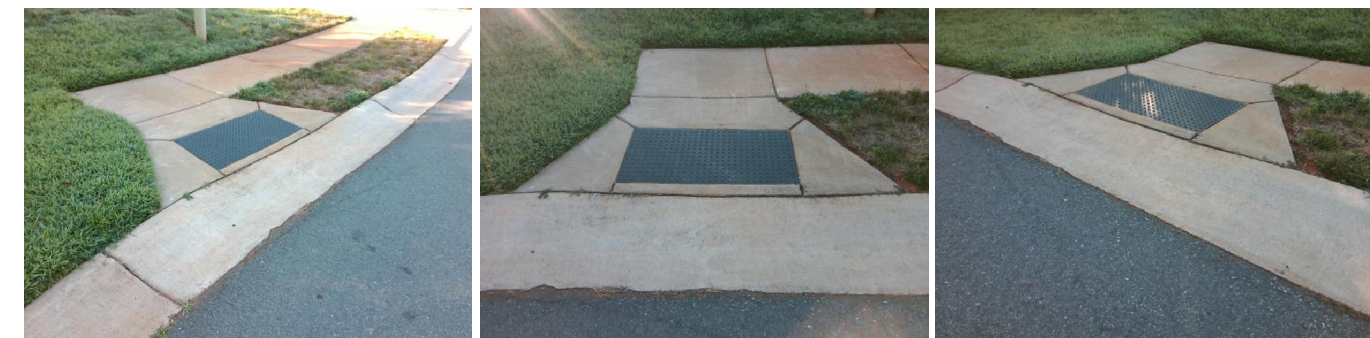
| ADA ID: 4E281001DBDE | Ramp Type: Perp | Initial Pass/Fail: Fail | Overall Compliance: No |

**Not Found, R304.5.3**

| Compliance | Description | Data | Compliance | Description | Data |
|---|---|---|---|---|---|
| Yes | Ramp Width (in) | 48.0 | No | Ramp XSlope (%) | 11.9 |

**Remove & Replace Entire Ramp.**
