# Access Compliance Report

## Public Rights-of-Way

| Intersection ID: 23352 | Main Street: LANCER_DR | Cross Street: LONDONTOWNE_DR | Location: NE |
| ADA ID: 4F28A1670DD1 | Ramp Type: PerpDiag | Initial Pass/Fail: Fail | Overall Compliance: No |

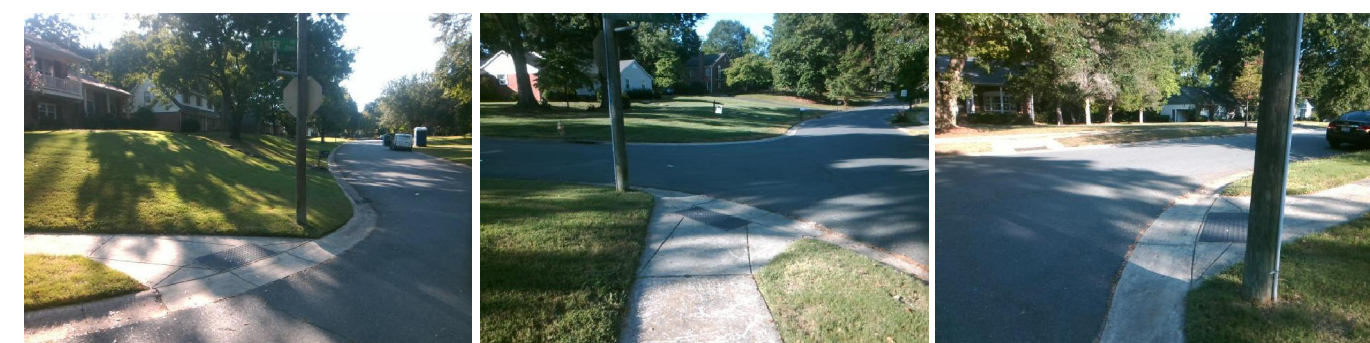
| Severity Score: 8.75 | | | |

**Not Found, R304.5.1**

| Compliance | Description | Data | Compliance | Description | Data |
|---|---|---|---|---|---|
| No | Ramp Width (in) | 40.5 | Yes | Ramp XSlope (%) | 0.4 |

**Remove & Replace Curb Ramp With Two New Directional Ramps or Equivalent.**
