# Access Compliance Report

## Public Rights-of-Way

### (Curb Ramps)

| Intersection ID: 48948 | Main Street: BIRCHLEY_CR | Cross Street: DAVID_JENNINGS_AV | Location: W |

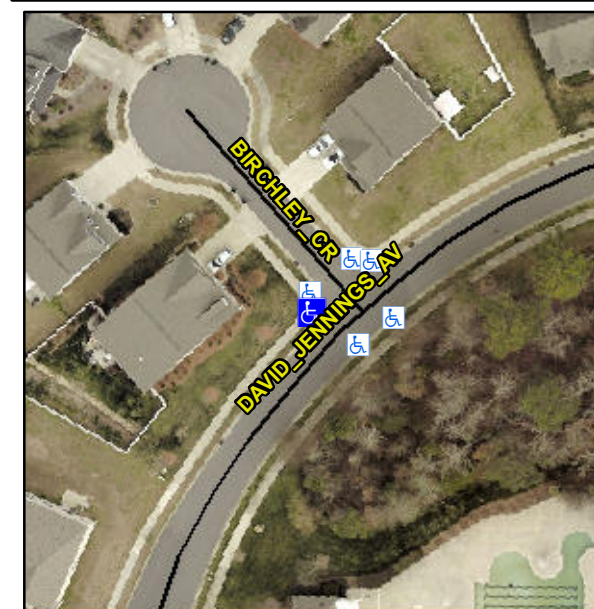
| ADA ID: 4F632B588534 | Ramp Type: Perp | Initial Pass/Fail: Fail | Overall Compliance: No |

**Not Found, R304.5.1**

| Compliance | Description | Data | Compliance | Description | Data |
|---|---|---|---|---|---|
| No | Ramp Width (in) | 47.0 | Yes | Ramp XSlope (%) | 1.8 |

**Remove & Replace Entire Ramp.**
